To: All U.S. and Canadian Volvo Retailers
Subject: Service Action – S10101

<h1>Quality Bulletin</h1>				
TITLE: Service Action S10101: AC Hose Grommet, XC40 Recharge Model Year 2021				
GROUP: 8741	CAT/NO: S10101	ISSUING DEPARTMENT: Product, Safety and Compliance	CAR MARKET: United States and Canada	
REVISIONS:			ISSUE DATE: 2021-06-10	STATUS DATE: 2021-06-10
Page 1 of 3

Title	Connector Block to Air Conditioning Compressor (AC) Line	Page	1 (4)
Action	Adjustment	Operation number:	97768-2

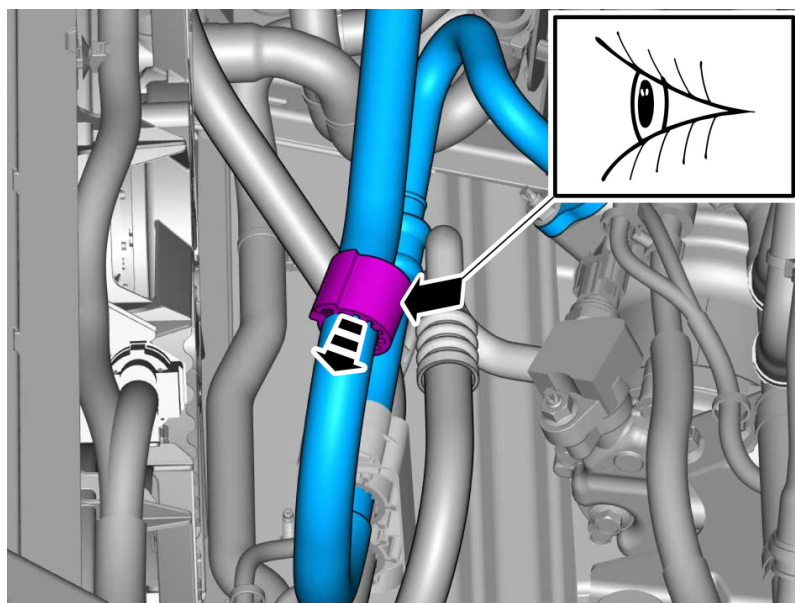
Note! Use soap solution.

Pull the component in direction of the arrow.

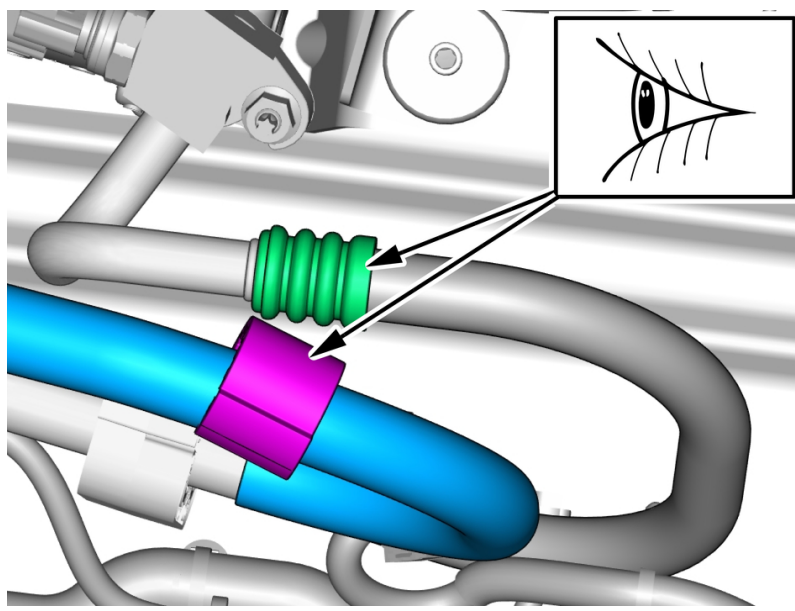
Caution! Make sure that the component is positioned correctly.

Adjust the position of the component according to image.
