# Technical Journal

## HV Battery Balancing Procedure

REF NO:  
TJ 35897.1.2ISSUING DEPARTMENT:  
Technical ServiceCAR MARKET:  
United States and CanadaPARTNER:  
3 US 7510 Volvo Car USAISSUE DATE:  
2021-07-14STATUS DATE:  
2021-07-15FUNC GROUP:  
3113FUNC DESC:  
Battery, high voltage

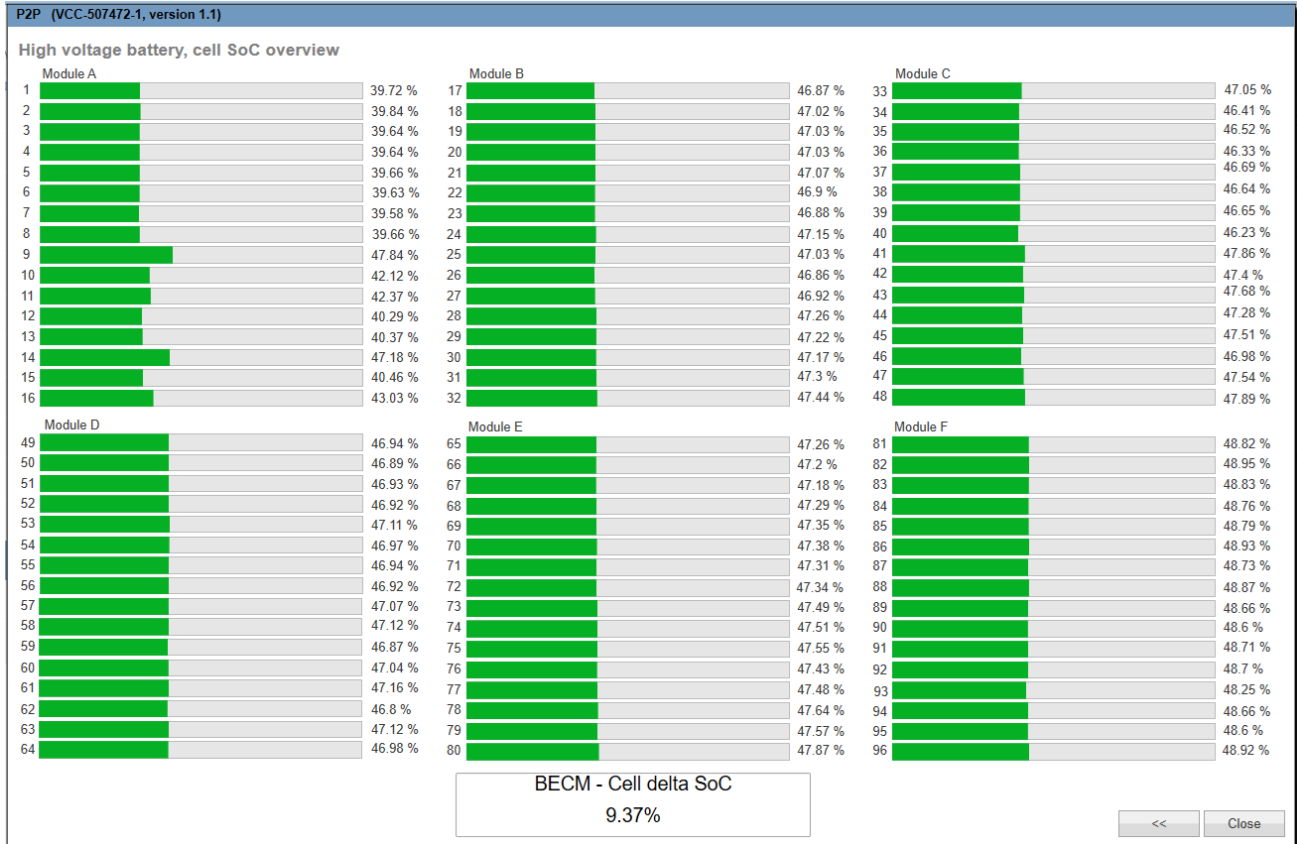
| File Name | File Size |
|---|---|
| UnbalancedCellSOCExample.png | 0.1081 MB |

If a vehicle comes into the shop with any of the cell balancing DTCs listed below, no obvious signs of cell failure, and having voltage and/or SOC patterns that appear erratic (see attached pictures for examples), the vehicle could be a candidate to have the cell balancing procedure outlined in the Service section performed.

The following procedure will allow the battery to balance itself out.
