# Drive Shaft Inboard Joint Boot Leak

YEAR(S)	MODEL(S)	ADDITIONAL INFORMATION
2019 - 2020	GX460

Some 2019 – 2020 model year GX 460 vehicles may exhibit a grease leak from the edge of the inboard joint boot of a front drive shaft where the clamp is located. This condition may appear in vehicles with less than 25,000 miles with no apparent damage to the boot. Follow the Repair Procedure in this bulletin to address this condition.

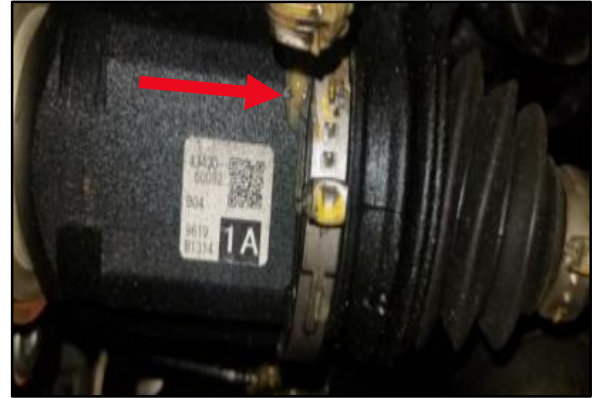
**Figure 1. Leak Example**

1. Does the vehicle exhibit a leak from the inboard joint boot of the front left-hand or right-hand drive shaft where the clamp is located?
  - **YES** — Continue to step 2.
  - **NO** — This bulletin does NOT apply. Continue diagnosis using the applicable Repair Manual.

5. Reassemble the inboard joint with the NEW boot kit.  
Refer to TIS, applicable model and model year Repair Manual:
  - 2019 – 2020 GX 460:  
*Drivetrain – Drive Shaft/Propeller Shaft* – [“Drive Shaft / Propeller Shaft: Front Drive Shaft Assembly: Reassembly”](#)

6. Install the inboard joint with the NEW boot kit.  
Refer to TIS, applicable model and model year Repair Manual:
  - 2019 – 2020 GX 460: *Drivetrain – Drive Shaft/Propeller Shaft* – [“Drive Shaft / Propeller Shaft: Front Drive Shaft Assembly: Installation”](#)
