SIB 61 08 21

2021-07-21

CIGARETTE LIGHTER IS DIFFICULT TO PULL OUT

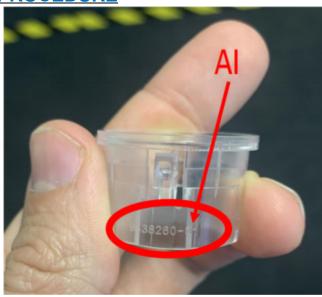
The cigarette lighter is difficult or impossible to pull it out.

Ring light in the center console socket is deformed.

Remove the socket and replace the clamping ring with part number

61 34 9438260 Clamping ring for 12 V power socket.

Note: A clamping ring with the revision index (AI) -02 or higher must be installed.

Alternatively, a ring light with part number 61 42 7947770 Ring light without LED can also be used on vehicles without Ambient Lighting.
