SIB 64 03 21

AIRFLOW RATE IN THE VEHICLE INTERIOR IS TOO LOW

This Service Information Bulletin (Revision 2) replaces SI B64 03 21 **dated July 2021**.

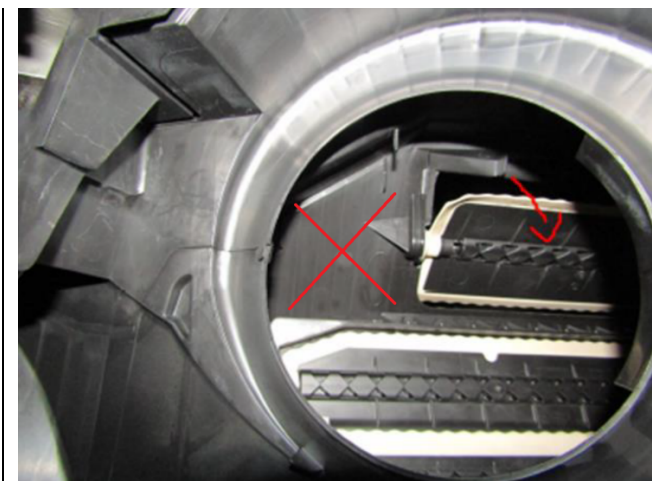
The fresh air flap can be over-driven (pushed past its normal end stop) when the microfilter is replaced. The regular opening and closing of the fresh air flap can no longer be guaranteed.

5. Check correct position of the fresh air flap through the blower motor opening, or using a borescope from the microfilter opening (NOTE: This flap is the top of three flaps).

Activate and deactivate the fresh air/air recirculation function on the air conditioning control panel or CID menu and observe whether the functionality of the flap is OK.

6. If the flap system is not OK, try to correct the flap by hand. See direction of arrow.

7. Once moved back past the end point, the flap **may** not function properly.
- After moving flap manually, use the test plan ABL to re-initialize/address the stepper motor position
  - Allow vehicle to enter sleep mode after running the test plan prior to testing flap positioning
  - If still not operational, then you may have to remove the stepper motor to check for damage. Once repaired run the ABL to initialize the stepper motors and allow the vehicle to enter sleep mode before testing.
