Knocking Noise From Fuel Tank Area

Service Category Engine/Hybrid System

Section Fuel System

YEAR(S)	MODEL(S)	ADDITIONAL INFORMATION
2016 - 2022	RX350

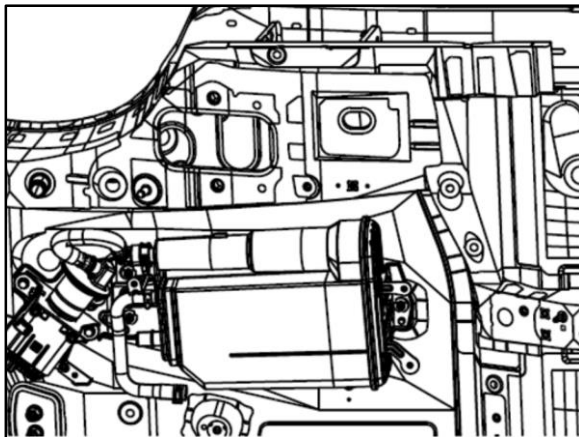
Figure 1. Without Pulsation Damper Valve Assembly Installed

The NEW part can be identified by the addition of a bracket and valve assembly attached to the charcoal canister.

- **YES** — This bulletin does NOT apply. Continue diagnosis using the applicable Repair Manual.
- **NO** — Continue to step 3.
