# Squeak Noise Over Uneven Surfaces With Suspension in Low Height Position

YEAR(S)	MODEL(S)	ADDITIONAL INFORMATION
2018 - 2020	Land Cruiser

Some 2018 – 2020 model year Land Cruiser vehicles equipped with Active Height Control may exhibit a squeak noise from the rear of the vehicle over uneven surfaces when the suspension is set to the low height position. The squeak noise is caused by contact between the passenger rear lower control arm and lower control arm support bracket. Follow the Repair Procedure in this bulletin to address this condition.

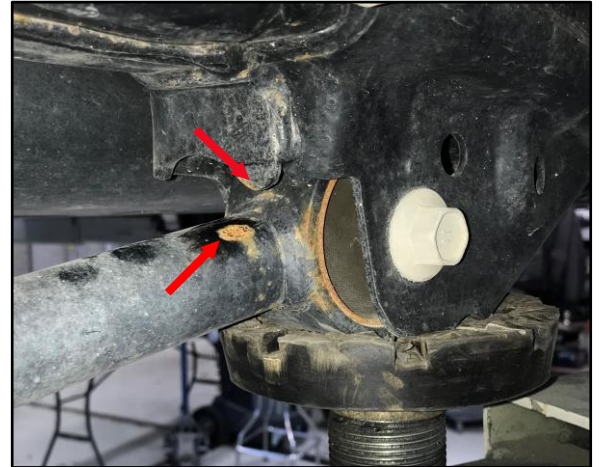
**Figure 1.**

1. Confirm the condition exists.  
 Set the suspension height to neutral or high and visually inspect the passenger rear lower control arm and lower control arm support bracket.  
 Are there signs of contact/witness marks between the two components?
  - **YES** — Sublet the vehicle to a qualified collision repair facility for repair.
  - **NO** — This bulletin does NOT apply. Continue diagnosis using the applicable Repair Manual.

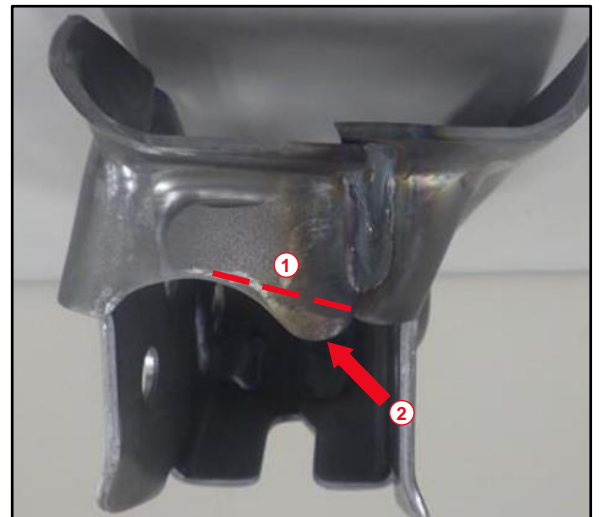
**Figure 2.**

<b>1</b>	<b>Cut Line</b>
<b>2</b>	<b>Excess (Remove Less Than 5 mm)</b>

2. Disconnect the lower control arm from the bracket.  
 Refer to TIS, applicable model and model year Repair Manual:
  - 2018 – 2020 Land Cruiser:  
*Suspension – Rear Suspension* – “Rear Suspension: Rear Lower Arm: [Removal](#)”
3. Using masking tape, mark the support bracket to use as a guide for removing excess material.

4. Using a cut-off wheel, remove the excess material from the control arm bracket.

**Do NOT remove more than 5 mm. Removing more than 5 mm could negatively impact the strength of the component.**
