MBUX multimedia system: XENTRY Diagnosis message  
"The MBUX multimedia system: Control unit ABNORMAL"

| Topic number | LI82.85-P-071394 |
| Function group | 82.85 - Navigation and Communication systems |
| Validity | Model series 118, 167, 177, 213, 238, 247, 253, 257, and 290 with code 548/549 |

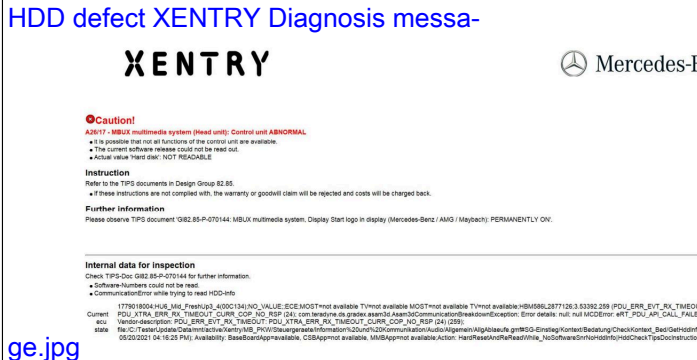
In XENTRY Diagnosis, the message "A2617 - MBUX multimedia system (head unit): Control unit ABNORMAL" appears (see attached)

| Attachments | |
|---|---|
| <p><a href="#">HDD defect XENTRY Diagnosis messa-</a></p> | XENTRY Diagnosis message HDD check |

Perform software update of MBUX multimedia system (A26/17).

If the software update is not possible, or the problem remains after the update, then replace the internal hard drive.

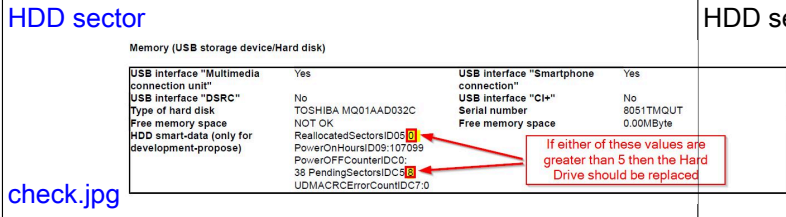
A value greater than "0" is usually shown in the MBUX control unit log, under Memory (USB storage device/hard drive), HDD smart-data and either "ReallocatedSectorsID05" or "PendingSectorsIDC5" (see attached). In some instances, only a question mark may be present as the data cannot be retrieved.

| Attachments | |
|---|---|
| <p><a href="#">HDD sector</a></p> | HDD sector check data |
