**October 21, 2021**

Version 3

## 2018-20 Accord: Rear Tray Rattles

Supersedes 19-044, dated October 1, 2021, to revise the information highlighted in **yellow**.

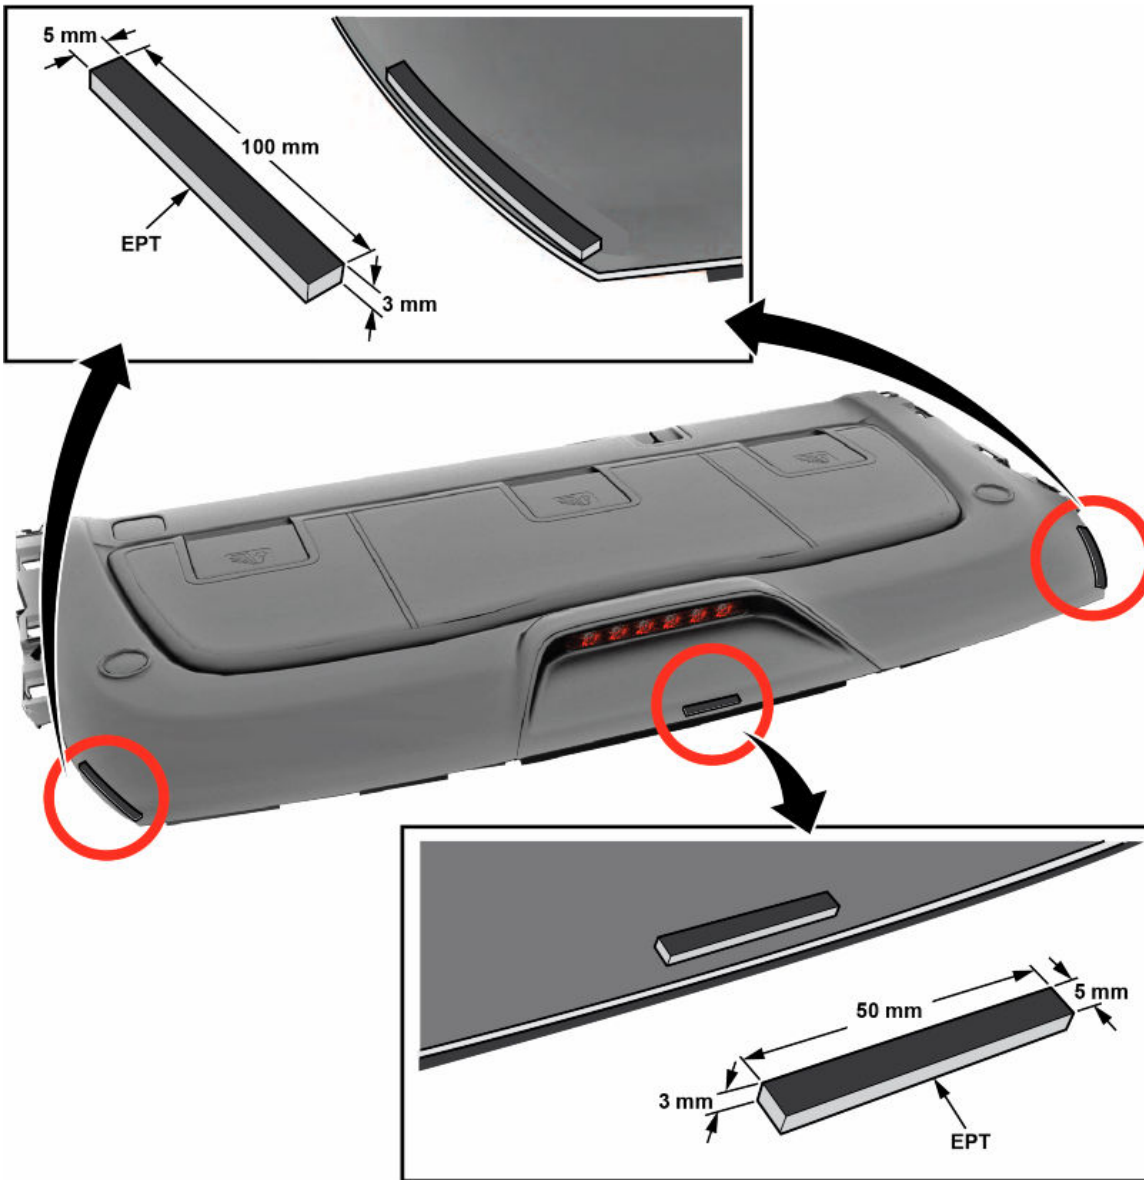
The rear tray may be warped in the back corners.

7. Cut two pieces of EPT foam 5 mm X 100 mm and 5 mm X 50 mm as shown below.

8. Clean the surface of the rear shelf where the EPT foam will be attached. Then, attach the EPT foam as shown.

NOTE: Make sure to center the EPT foam when applying to the tray.
