Technical Service Bulletin

90 Instrument cluster: trip odometer and/or clock sporadically resets to zero - MY20

90 21 18 2062368/3 October 25, 2021. Supersedes Technical Service Bulletin Group 90 number 21-13 dated August 19, 2021 for reasons listed below.

Model(s)	Year	VIN Range	Vehicle-Specific Equipment
Q3	2020	All	Digital Instrument Cluster

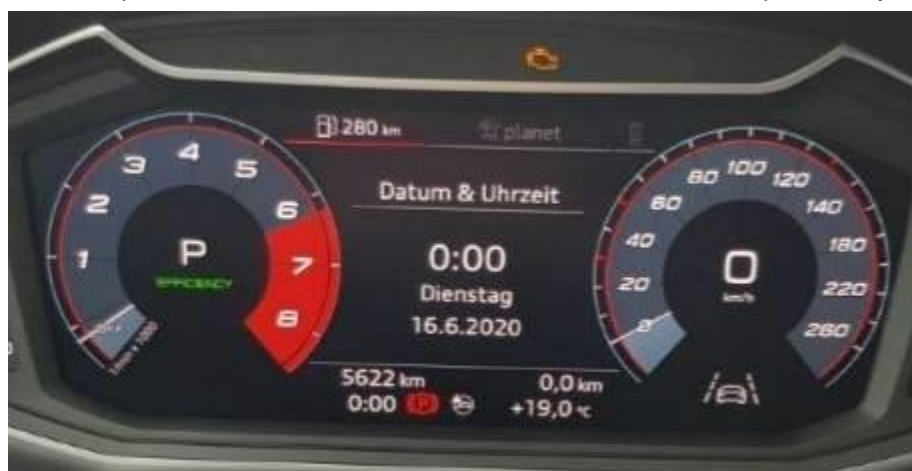
- The trip odometer and/or the clock in the instrument cluster sporadically reset to zero (Figure 1).

Figure 1. Clock and trip odometer reset to zero.

A software issue in the instrument cluster can cause it to reset on start-up clearing the clock and trip odometer.

- Update the instrument cluster using either Method 1 or Method 2 according to TSB 2056558: *91 MIB2+ Software Update Instructions* use SVM code FPKWW4310.

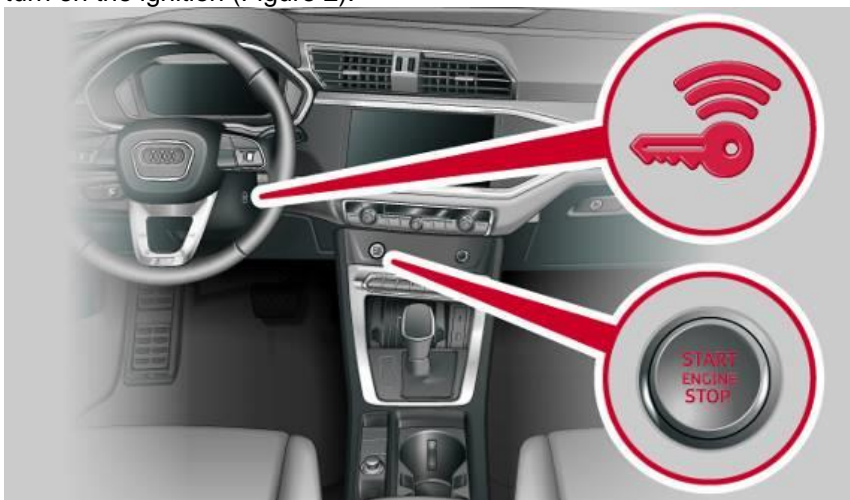
Figure 2. Key reader coil location.

- Affix the vehicle key to the key reader coil before starting the update (for example with adhesive tape), then turn on the ignition (Figure 2).
