# Technical Service Bulletin

## 91 No diagnostics communication to the telematics control module

91 21 45 2056076/13 October 25, 2021. Supersedes Technical Service Bulletin Group 91 number 21-81 dated March 15, 2021 for reasons listed below.

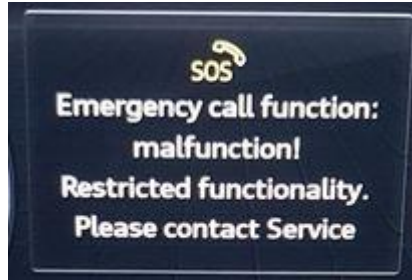
- An SOS Warning might be displayed in the instrument cluster (Figure 1).

*Figure 1. Emergency call malfunction warning.*

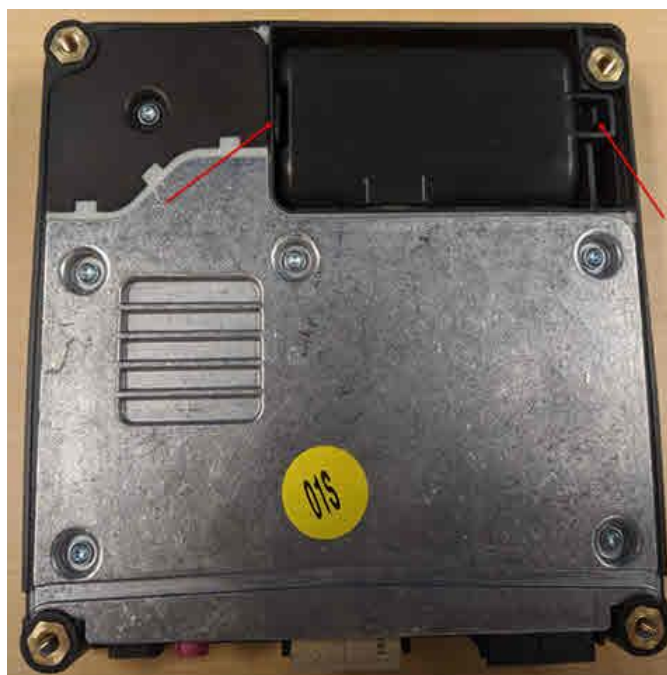
**Figure 2.** Backup battery compartment location.

1. Remove and unplug the telematics control module, J949 (address word 0075) according to the Elsa Repair Manual.
2. Open the battery compartment of the telematics control module, J949 (address word 0075) and disconnect the backup battery (Figures 2 - 3).

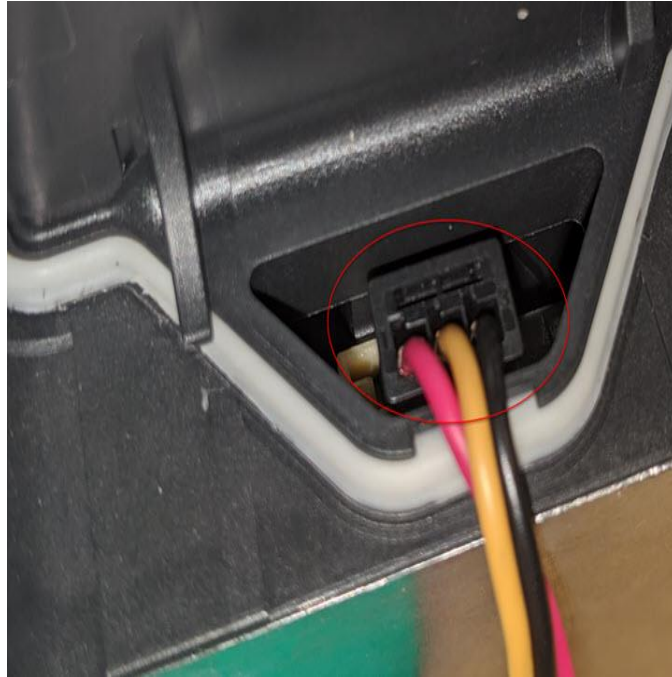
*Figure 3. Backup battery connector (no release mechanism).*
