Technical Service Bulletin

Subject: AIR CONDITIONER DOES NOT BLOW COLD AIR DUE TO CRACKED COOLER PIPE (HI) A (REFRIGERANT LEAK)	Bulletin No.: 07-002/21
	Last Issued : 10/08/2021

2016-2020 MX-5 with VINs lower than JM1ND*****418386 (built before Sep. 10, 2020)

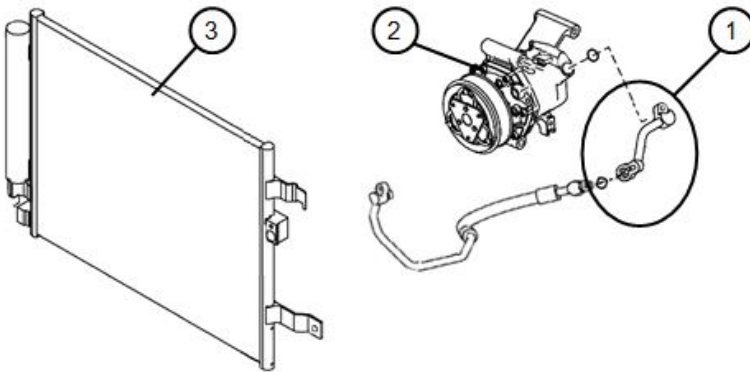
Some vehicles may experience that the A/C does not blow cold air (blows warm air) due to a refrigerant leak. This is caused by a crack in the cooler pipe (HI) A (1) due to engine vibration. To correct this issue, the material and thickness of the cooler pipe (HI) A has been changed to increase durability (pipe diameter has been changed from 12mm to 16mm).

(1)	Cooler pipe (HI) A
(2)	A/C compressor
(3)	Condenser

1. Verify customer concern.
2. Inspect the cooler pipe (HI) A.
 - If the cooler pipe (HI) A is cracked, replace the cooler pipe (HI) A with a modified one according to the instructions on MGSS (REFRIGERANT LINE REMOVAL/INSTALLATION).
 - If the cooler pipe (HI) A is not cracked, this TSB is not applicable. Refer to troubleshooting procedure on MGSS (NO COOL AIR [CLIMATE CONTROL SYSTEM]).
3. Verify repair.
