Technical Service Bulletin

Mazda North American Operations
Irvine, CA 92618-2922

Subject: INSUFFICIENT A/C PERFORMANCE/LACK OF AIR BLOWING FROM VENTS/DUCTS	Bulletin No.: 07-004/21
	Last Issued : 10/08/2021

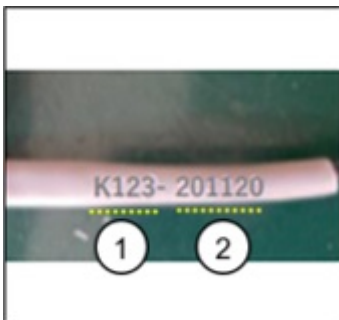
Description of the lot number on the evaporator temperature sensor:

Modified parts: The lot number "K123-201120" (production date: November 20, 2020) and later are modified parts.

(1) First 4 digits of parts number **K123**-61-J22

(2) Production date in YYMMDD format.
"201120" means "November 20, 2020"
