21-2295

TECHNICAL SERVICE BULLETIN

Rubbing Noise At Front Of Vehicle While Driving And/Or DTCs C0031 And/Or C0034 - Built On Or Before 14-Jun-2021

Ford
2021 F-150

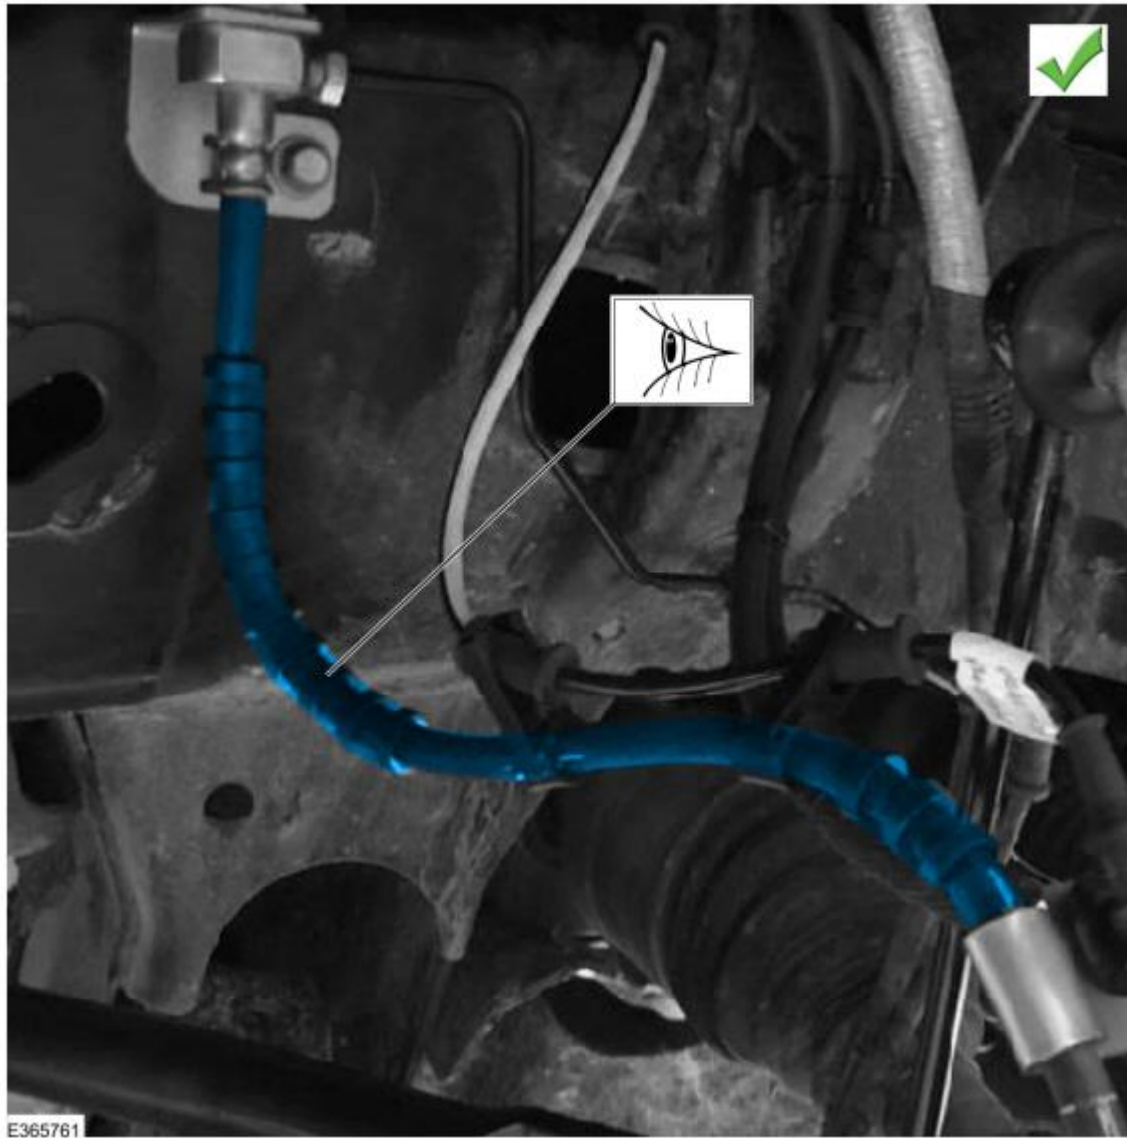
Figure 1 - Correct routing

NOTE: The flexible hoses must travel downward on the frame side before bending and bend near where they enter the bracket secured to the steering knuckle. There should be greater than 3/4 inch (19 mm) clearance between the brake flexible hose and the wheel/tire assembly.

3. Replace the affected front brake flexible hose(s). Refer to Workshop Manual (WSM), Section 206-03. When installing the new hose(s), they must travel downward on the frame side before bending toward the steering knuckle and then bend near the bracket secured to the steering knuckle. (Figure 1)

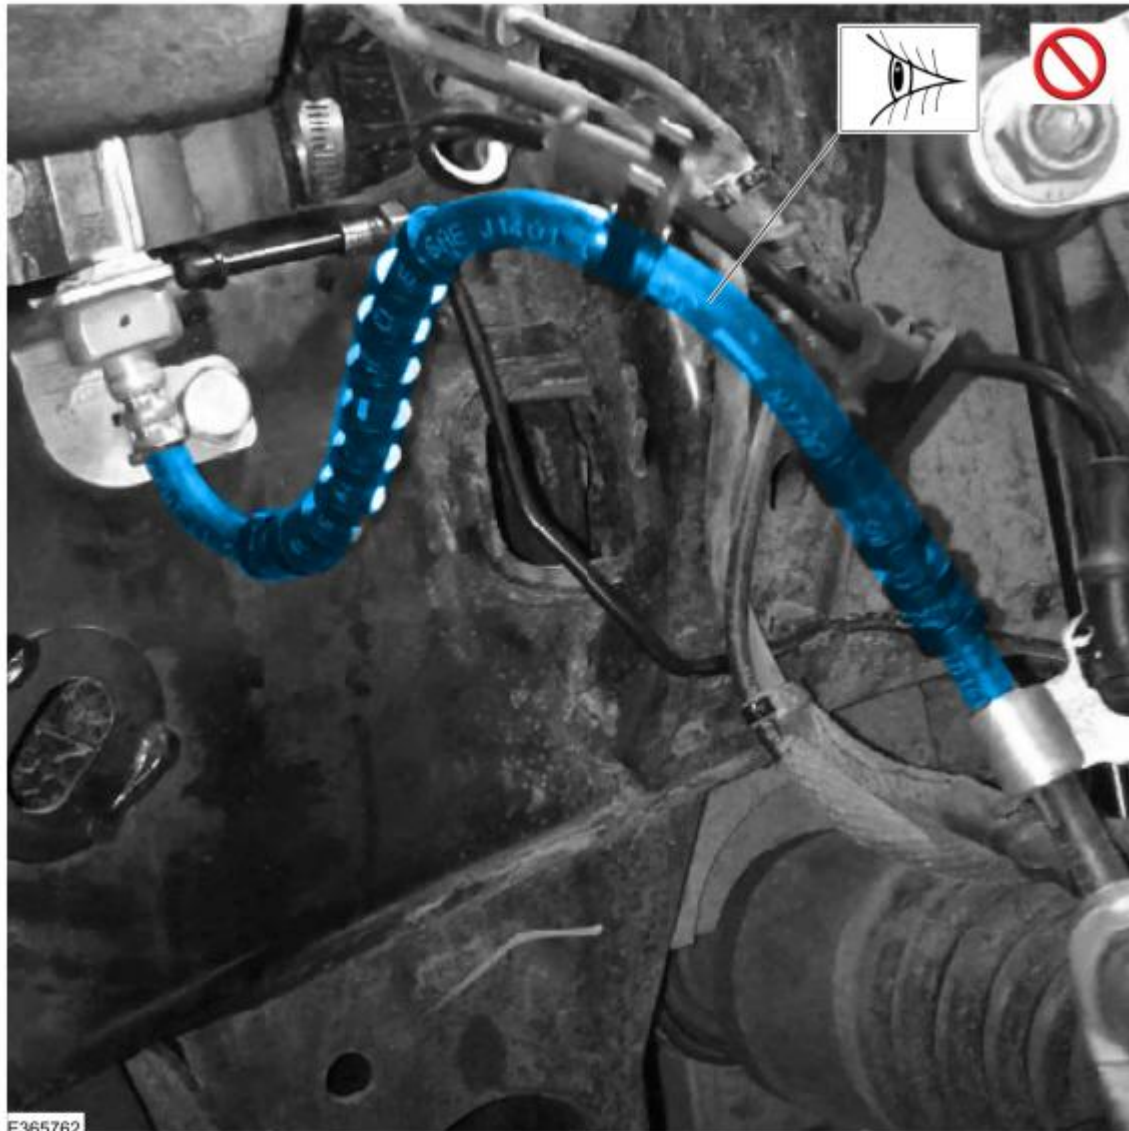
Figure 2 - Incorrect routing

Issue: Some 2021 F-150 vehicles built on or before 14-June-2021 may exhibit a rubbing noise at the front of the vehicle while driving and/or diagnostic trouble codes (DTC) C0031 and/or C0034 in the anti-lock brake system (ABS) module. This may be caused by an incorrectly routed front brake flexible hose. To correct the condition, follow the Service Procedure to inspect the front brake flexible hose routing.

4. Inspect the affected wheel speed sensor harness(es). Is the wheel speed sensor harness damaged?

- (1). Yes - replace the affected wheel speed sensor.
