**No.: 21TS-14**  
October 2021

SUBJECT: **Gen 5 DD15 Exhaust Valve Adjusting Screw Excessive Wear & Increased Engine Idle Speed w/ DiagnosticLink Routine Impact**

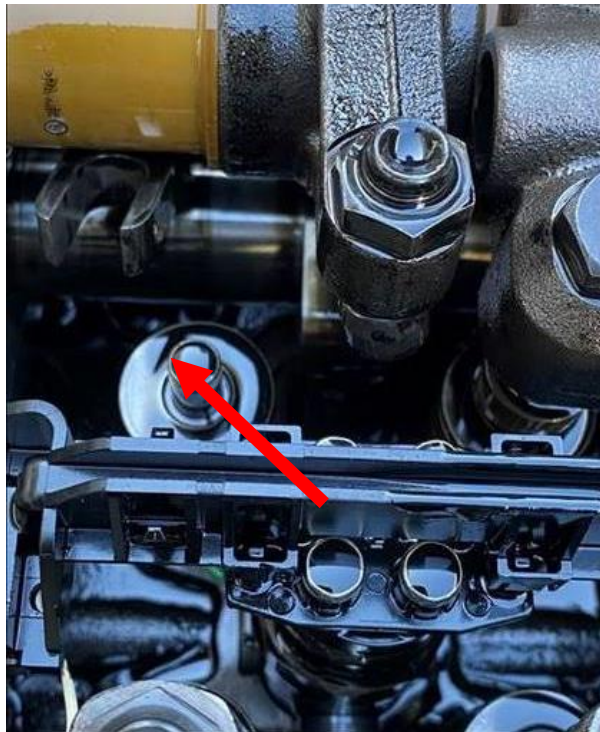
**Figure 1. Exhaust Valve Bridge Out of Position**

Excessive exhaust valve adjusting screw wear results in excessive valve lash.

1. Did the valve bridge fall out of position?
  - a) Yes; replace the affected valve bridge **and** all six exhaust valve lash adjusting screws. Inspect the related valve train components on that cylinder for wear or damage. Do not replace the exhaust camshaft unless there is camshaft lobe damage.
  - b) No; go to step 2.

2. Measure exhaust valve lash on all six cylinders. Is any cylinder location equal to or greater than 1.0 mm (0.040 in.) of lash?
  - a) Yes; replace all six adjusting screws.
  - b) No; reset exhaust valve lash to the correct specification of 0.6 mm (0.024 in.) and verify complaint has been resolved.
