Subject: BLIND SPOT MONITORING (BSM) MALFUNCTION DUE TO REAR SIDE RADAR SENSORS INSTALLED FACING WRONG DIRECTION	Service Alert No.: SA-038/21
	Last Issued : 10/04/2021

2019-2021 Mazda3
2020-2021 CX-30

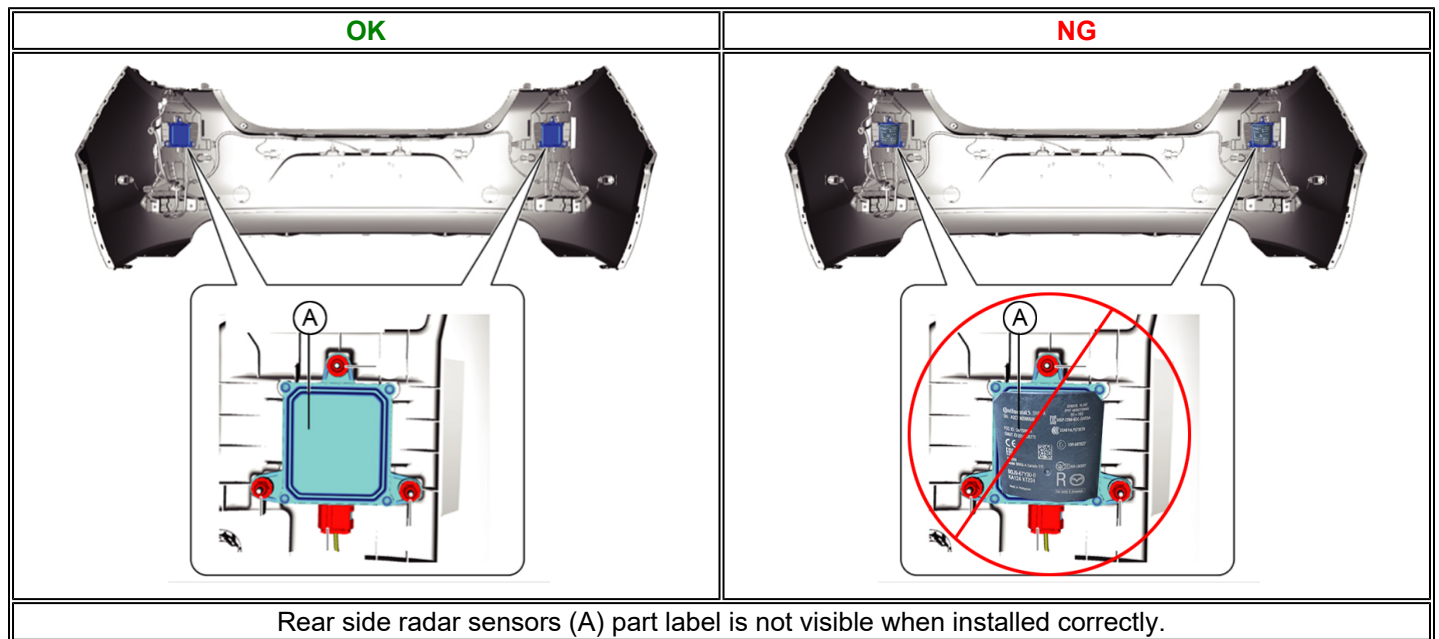
The Blind Spot Monitoring (BSM) system can malfunction with the following symptoms if the rear side radar sensors are installed facing the wrong direction.

- BSM system indicates vehicle on the opposite side.
- i-ACTIVSENSE indicator ring will not turn green
- Rear Cross Traffic Alert (RCTA) does not work
- Rear side radar sensor aiming may fail
- TPMS DTC(s) stored

1. Verify customer concern.
2. Inspect the rear side radar sensors.

Is the part label visible?

- **Yes:** Remove the rear side radar sensor(s) and install it correctly.
- **No:** This service information does not apply. Continue with normal diagnosis on MGSS.
