# Service Alert

<b>Subject:</b>  <b>CONNECTED VEHICLE SYMPTOM TROUBLESHOOTING</b>	<b>Service Alert No.: SA-013/21</b>
	<b>Last Issued : 10/13/2021</b>

2019-2021 Mazda3  
2020-2021 CX-30  
2021 CX-5  
2021 CX-9

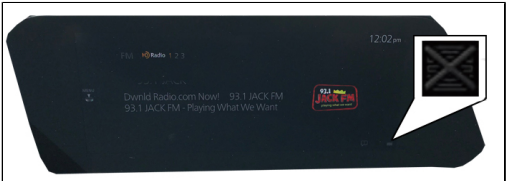
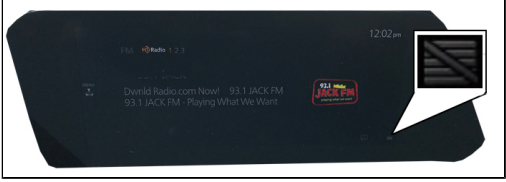
<p>3</p>	<p>MAZDA CONNECT connected vehicle reception strength icon shows "X" or "\".</p> <p>Mazda3, CX-30</p>

<p>No reception</p>	<ol style="list-style-type: none"> <li>1. Go to <a href="#">eMDCS Vehicle Inquiry</a>. Does eMDCS show CSP04 closed?             <ul style="list-style-type: none"> <li>• Yes - Customer opt-out. No action needed.</li> <li>• No - CSP04 is not shown. Go to next step.</li> </ul> </li> <li>2. Check for DTCs. Are there any DTC's stored?             <ul style="list-style-type: none"> <li>• Yes: Go to MGSS for normal DTC diagnosis.</li> <li>• No: Go to next step.</li> </ul> </li> <li>3. Confirm TCU software version is at the following using <a href="#">Version Check</a>.             <ul style="list-style-type: none"> <li>• CX-5 and CX-9: 10020 or later</li> <li>• CX-30 and Mazda3: 10004 or later</li> </ul> </li> <li>4. Disconnect battery terminal for 30 seconds, then test drive vehicle. Is the reception strength signal normal?             <ul style="list-style-type: none"> <li>• Yes: Repair complete.</li> <li>• No: Go to next step.</li> </ul> </li> <li>5. Perform TCU activation. Go to <a href="#">SA-004/21</a>. Is the reception strength signal normal?</li> </ol>

<ul style="list-style-type: none"> <li>• Yes: Repair complete.</li> <li>• No: Go to next step.</li> </ul> <p>6. Compare Tel antenna No. 1 signal strength with good one near by. Go to DIAGNOSTIC ASSIST FUNCTION [CONFIRM] MASTER UNIT (US)] Functional Inspection / Adjustment -&gt; Navigation System</p> <p><b>Good</b> - Contact Hotline for technical support</p>

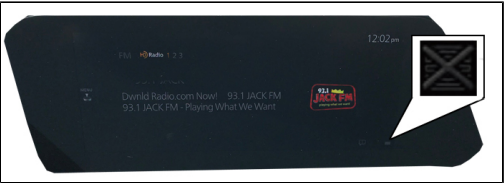
5	<p>2019 Mazda3 only</p> <ul style="list-style-type: none"> <li>The customer is not able to activate Connected Services via the MyMazda app after CSP06 completion.</li> <li>MAZDA CONNECT connected vehicle reception strength icon is missing or shows unsubscribed after CSP06 completion.</li> </ul>

<p>Improper telematics communication unit (TCU) software.</p>	<p>Go to <a href="#">CSP07</a> Repair instructions.</p>
6	<p>2020 Mazda3 only</p> <ul style="list-style-type: none"> <li>Infotainment center display does not provide the Authorization Code</li> <li>Infotainment center display "Software Update Error" message</li> </ul>

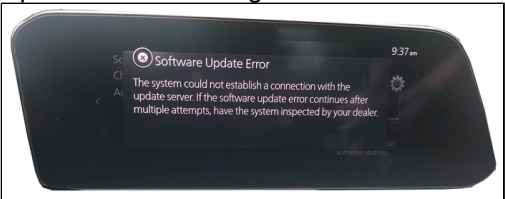
<p>Enrollment error</p>	<p>Go to <a href="#">SSPC1</a></p>
