SERVICE BULLETIN

APPLICABILITY: 2010-19MY Legacy and Outback
 2014-19MY Forester
 2012-19MY Impreza
 2013-19MY Crosstrek (Exc. 19MY PHEV)
 2015-19MY WRX
 2019-20MY Ascent

NUMBER: 16-103-16R

SUBJECT: Transmission Fluid Seepage

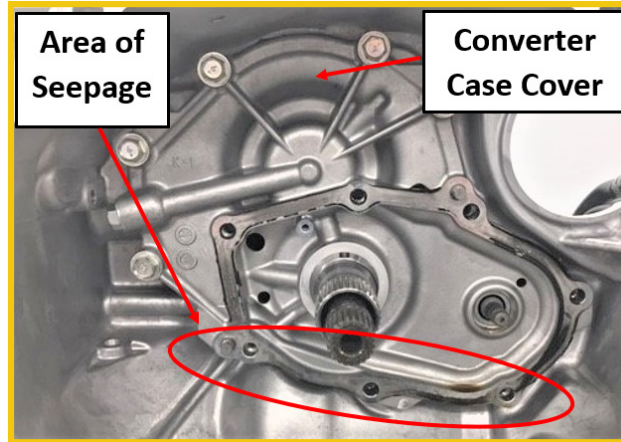
TR690 ONLY

Check the mating surface of the converter case cover for CVT fluid seepage.

- If CVT fluid is found leaking in this area, remove and re-seal the converter case cover. Refer to the “**Converter Case Cover Re-Sealing**” section of this bulletin. If NO CVT fluid is found leaking in this area, continue with the procedures for re-sealing the oil pump chain cover.

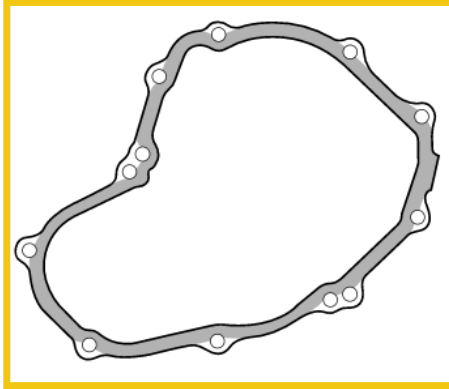
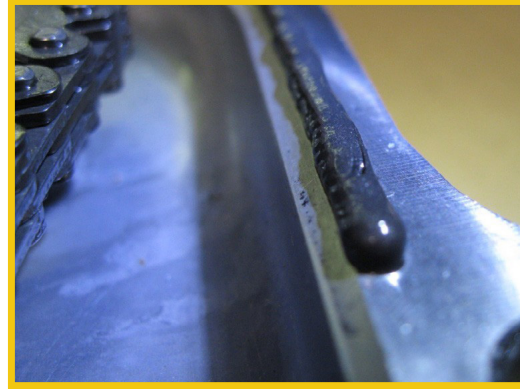
NOTE: As shown above, a properly applied, small bead of sealant will fill in the chamfered portion after the cover is installed. Do not use an excessive amount of sealant.

- **CAREFULLY** apply the new sealant bead to the converter case cover along the edge of the chamfer as shown

- Install the converter case case cover. Install the 5 – 12mm hex bolts and torque to **24Nm (17.7 ft.lbs)** in a crossing pattern.

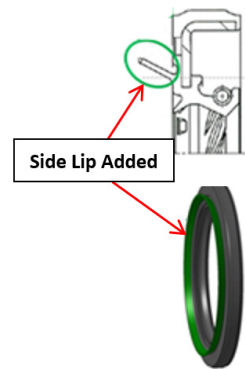
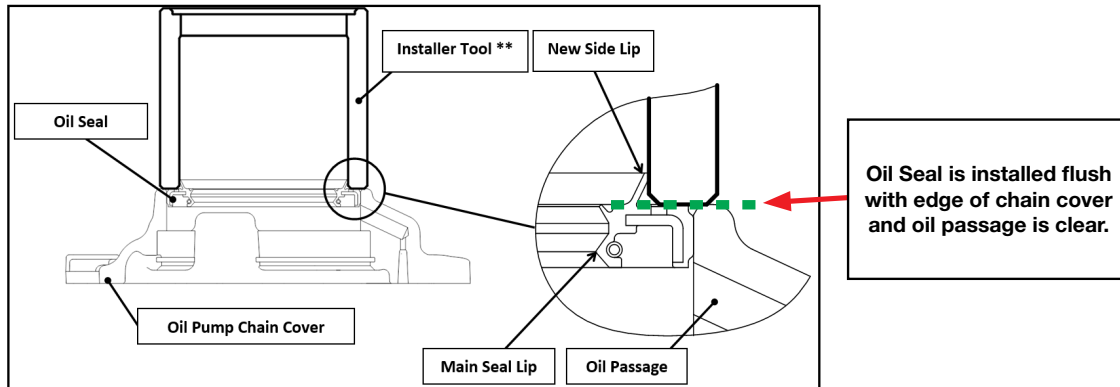
- The re-designed input shaft oil seal has a new side lip added to supplement the existing main seal lip. The purpose of the additional side lip is to direct the flow of dust and water around the seal and away from the sealing surfaces.
- Apply CVT fluid to the main seal lip **only** before installation.
- When installing this new seal, it is **STRONGLY** recommended to use the proper installer tool ****OPTIONAL Special Tool 927890000** as shown in the illustration below. Otherwise, If the seal were to be installed too deep into the bore of the chain cover (beyond flush with the chain cover edge as shown below), the oil passage may become restricted or blocked.

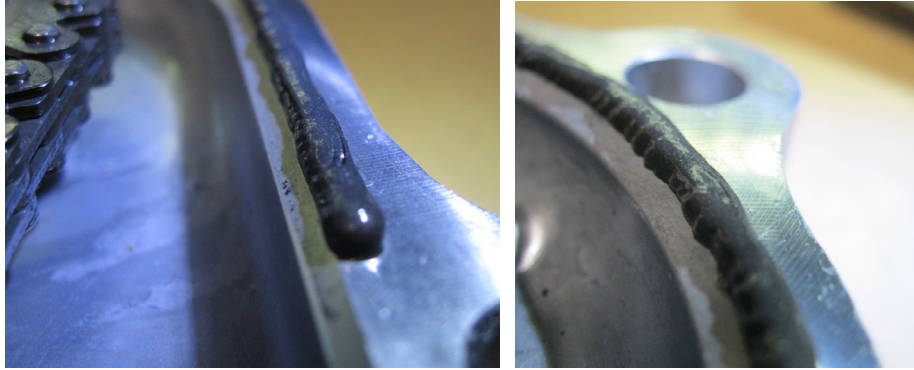
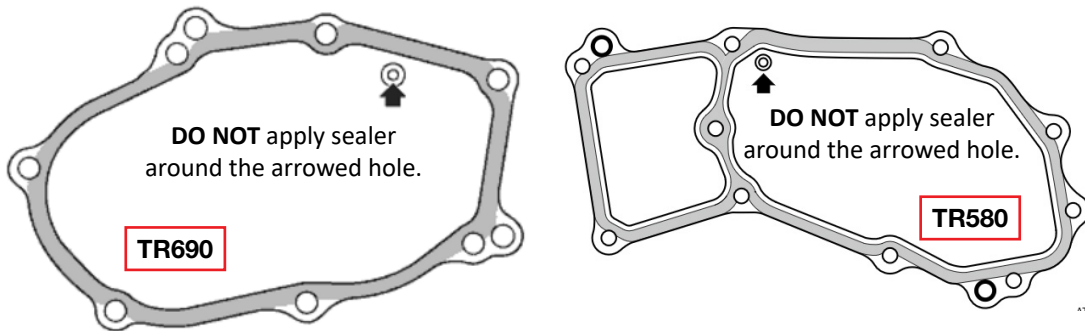
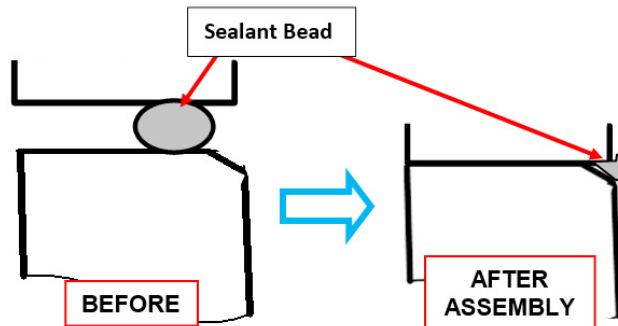
NOTE: As shown above, a properly applied, small bead of sealant will fill in the chamfered portion after the cover is installed. Do not use an excessive amount of sealant.

- Once both surfaces and the area surrounding the cover are completely clean, dry and the new input seal is properly installed, CAREFULLY apply the new sealant bead to the cover along the edge of the chamfer as shown below.
