# **TECHNICAL TOPICS BODY/CHASSIS**

## Seat Power Height Adjustment Motor Inoperative

12-22MY RR Evoque, 14-22MY RR Sport, 15-22MY Discovery Sport, 17-22MY Discovery, 18-22MY RR Velar, 20-22MY Defender, 17-22MY F-PACE, XF,XE, E-PACE 18-22MY I-PACE

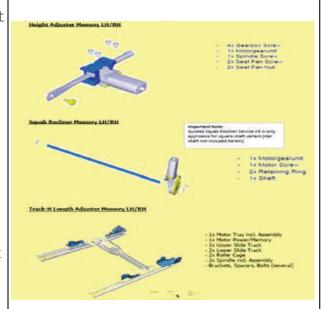
A customer may report that the power seat height adjustment function does not operate.

This may be caused by a seat height adjustment motor that has failed.

- The front seat height adjustment motor has now been released as a lower level repair and the replacement procedures has been added to the TOPIx Workshop Manual.
- Please refer to Workshop Manual > Section 501-10 Seating > Removal and Installation > Front Seat Height Adjustment Motor.
- The seat back frame no longer needs to be replaced to repair a failed seat height adjustment motor.
- Part numbers Land Rover = LR1549752 & LR154976, Jaguar T2H52345 & T2H52347.
