**October 26, 2021**

Version 4

## 2018-20 Accord: Rear Tray Rattles

Supersedes 19-044, dated April 23, 2019, to revise the information highlighted in yellow.

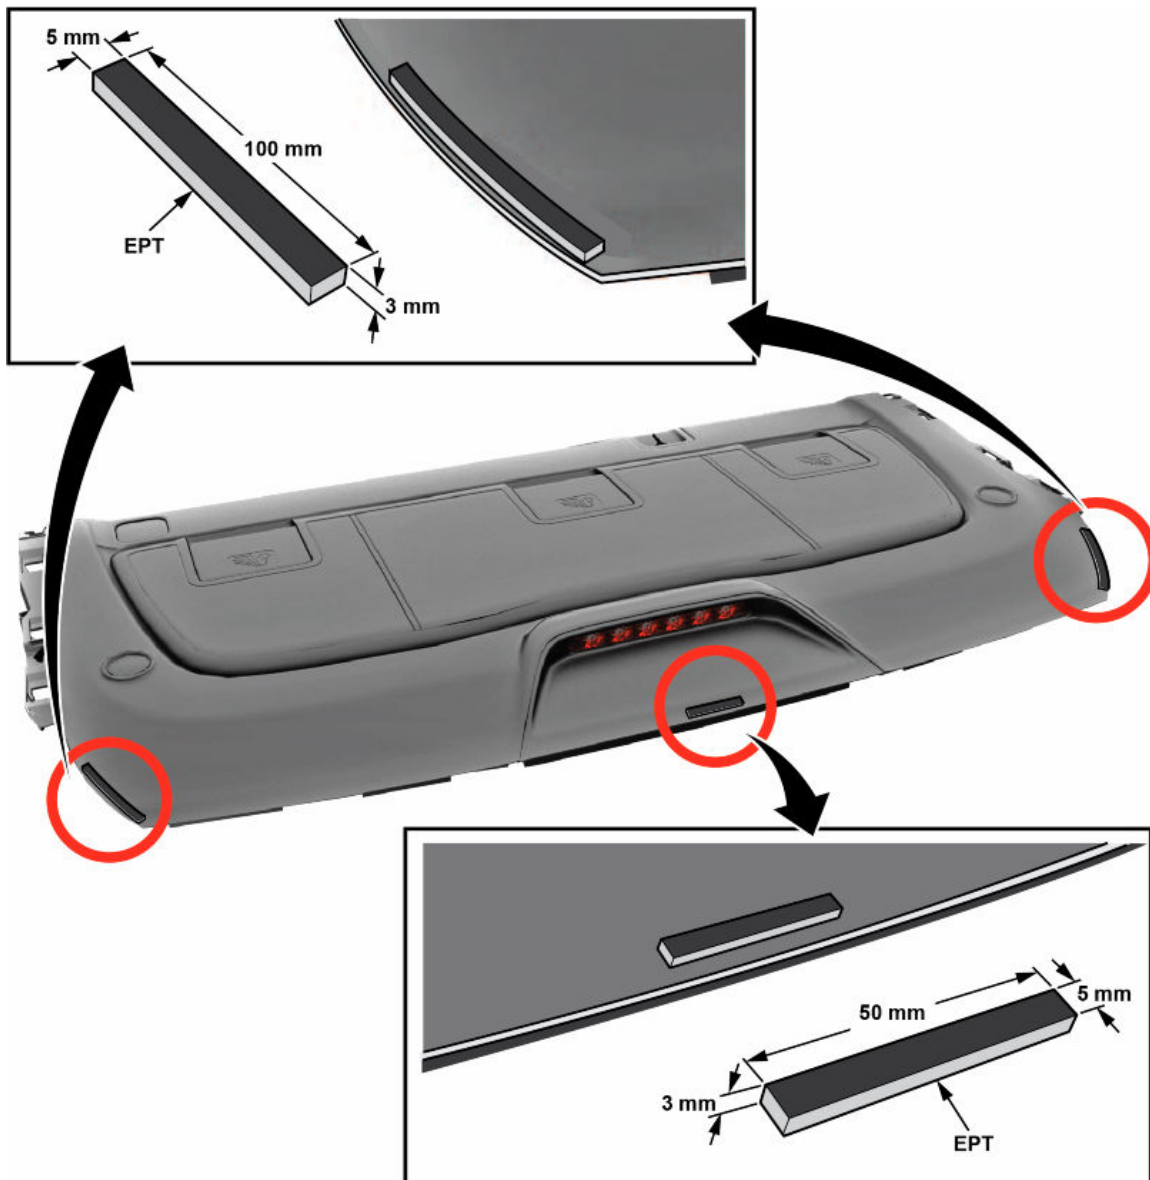
The rear tray may be warped in the back corners.

7. Cut two pieces of EPT foam 5 mm X 100 mm and 5 mm X 50 mm as shown below.

8. Clean the surface of the rear shelf where the EPT foam will be attached. Then, attach the EPT foam as shown.

NOTE: Make sure to center the EPT foam when applying to the tray.
