TECHNICAL SERVICE BULLETIN

Water Dripping Into The Front Passenger Side Footwell When A/C Is Operating - Built On Or After 01-Feb-2013

21-2379

Ford
2014-2020 Transit Connect

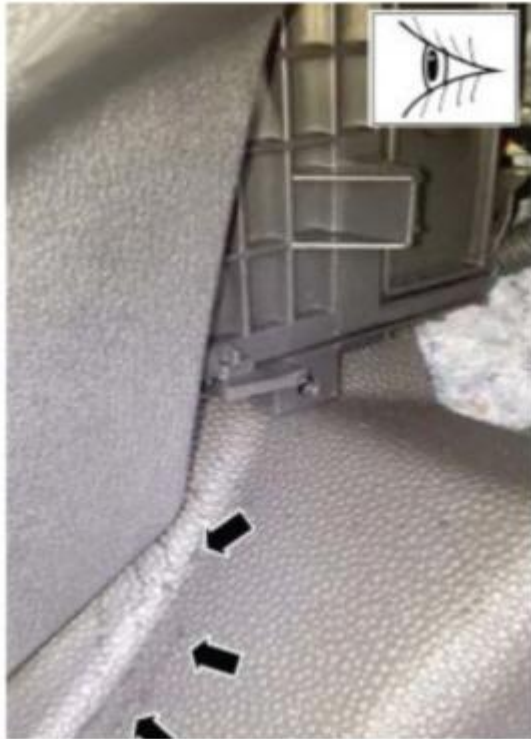
Figure 1

Issue: Some 2014-2020 Transit Connect vehicles built on/or after 01-Feb-2013 may exhibit water dripping into the passenger front footwell. This may be due to an excessive gap in the heating, ventilation, and air conditioning (HVAC) case allowing water to drip from the case when the air conditioning (A/C) is operating. To correct the condition, follow the Service Procedure steps to reseal the HVAC case.

1. Is the concern as shown in Figure 1, water dripping onto the trim panel, or Figure 2, water dripping onto the floor covering?
