Technical Service Bulletin

93 Repeated charge complete notifications received in the myAudi app

93 21 57 2064636/1 October 31, 2021.

Model(s)	Year	VIN Range	Vehicle-Specific Equipment
Audie-tron quattro, Audi e-tron sportback quattro	2020 - 2022	All	Not Applicable

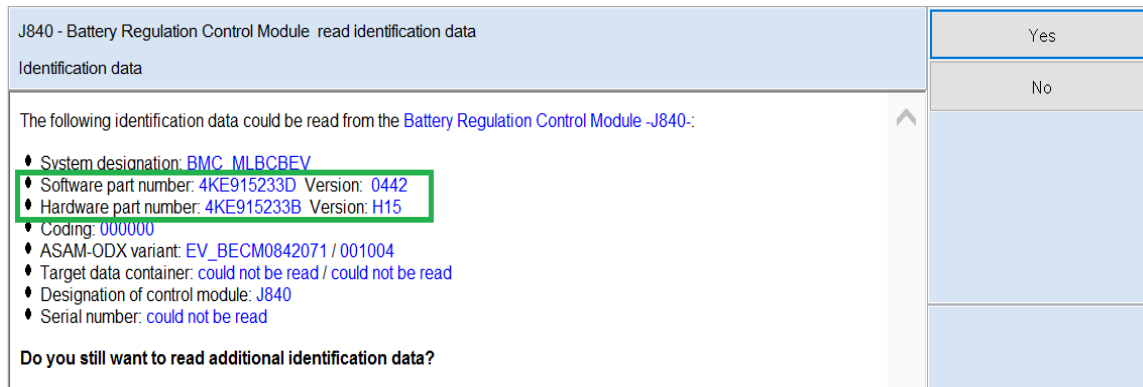
Figure 1. Identification of battery regulation control module.

The test plan will identify the J840 and ask “Do you still want to read additional identification data” (Figure 1). Make note of the installed software part number, hardware part number, and the software version, then select “Yes.”

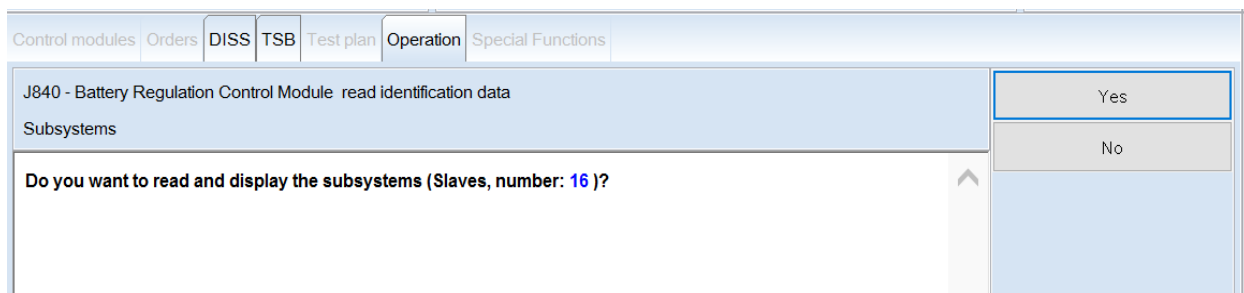
Figure 2. Subsystems screen.

After selecting yes in the previous step, the scan tool will ask if you want to read and display the subsystems, select “Yes” (Figure 2).

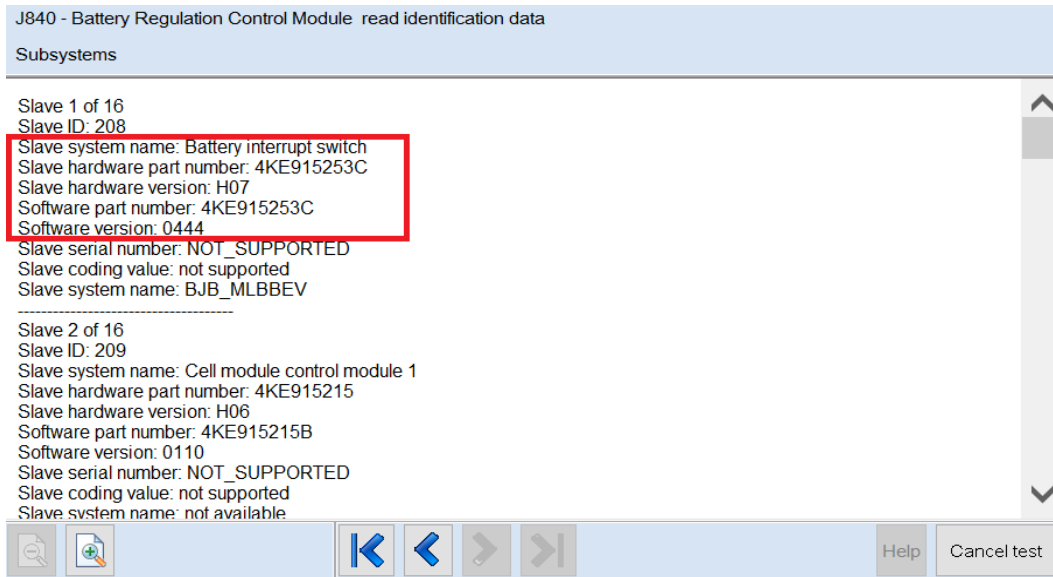
Figure 3. Identification of switching unit for high-voltage battery SX6.

3. After the scan tool reads the sub-control modules the screen will display them. The first control module should be listed as the battery interrupt switch, this is the switching unit for high-voltage battery SX6 (Figure 3).
