Countries: CANADA, UNITED STATES, MEXICO Document ID: IK0700115  
Availability: ISIS, Bus ISIS, FleetISIS, IsSIR Revision: 11  
Major System: EXHAUST Created: 8/26/2021  
Current Language: English Last Modified: 10/22/2021  
Other Languages: [Français](#) Author: William Knoth  
Viewed: 6973

Title: QLS Emergency Calibration

Applies To: Model Year 2016 ISX, A26 and EPA 2017 and Newer X15 / L9 / B6.7 Engines

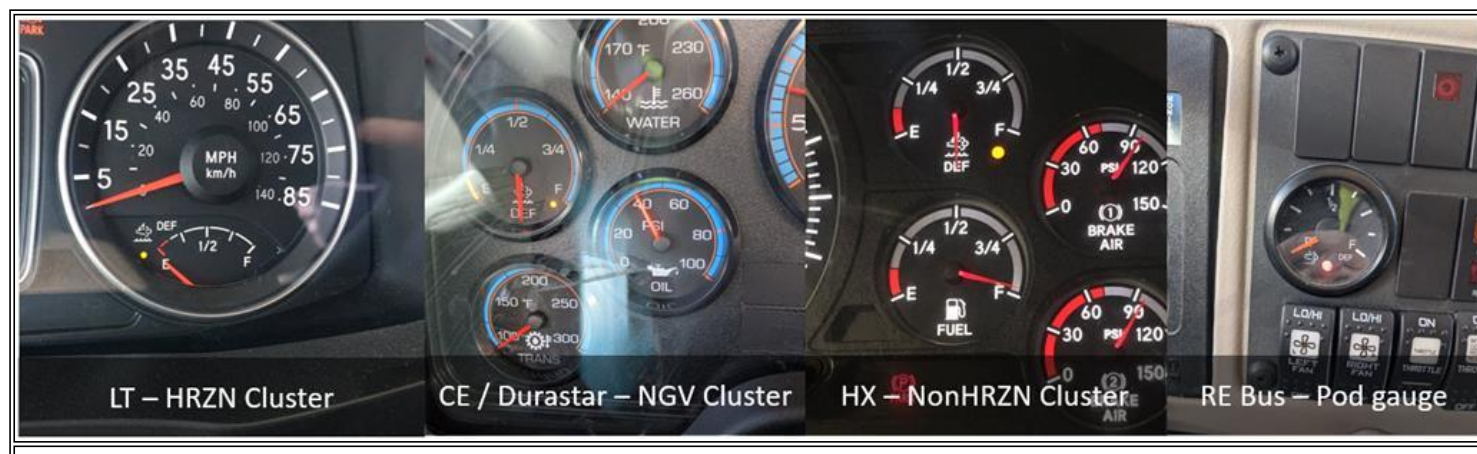
**Figure 1: DEF Level Gauge Reaction**

The DEF tank level gauge will NOT function with the QLS emergency calibration. It may show incorrect or empty at all times.

Item 1: DEF Level Gauge

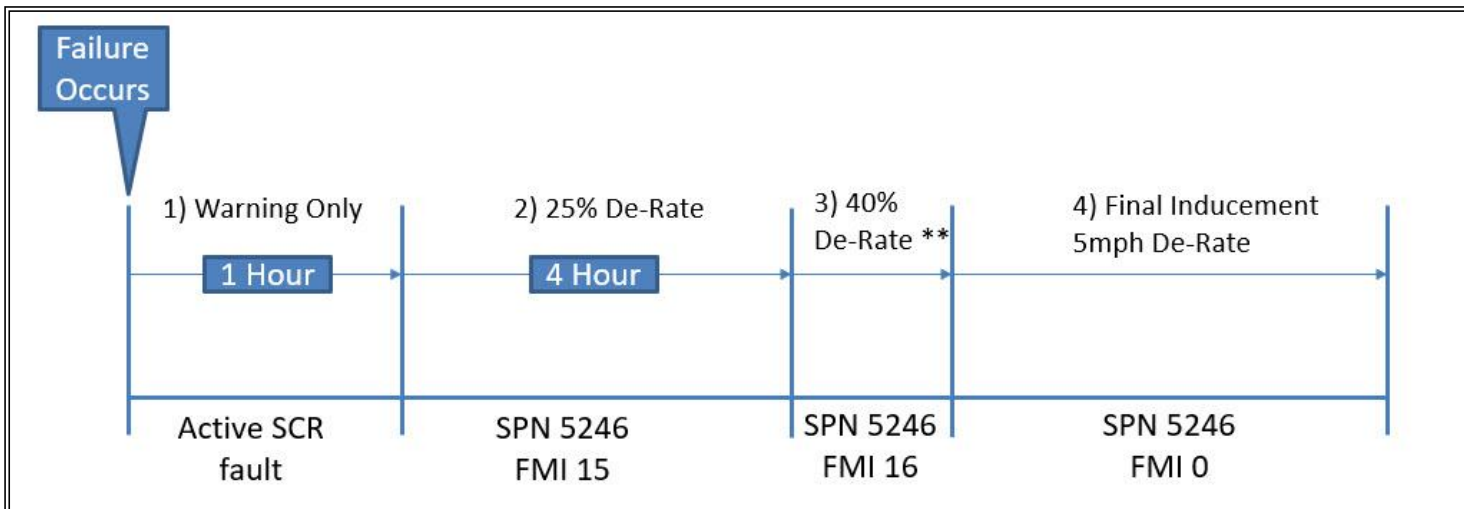
**Figure 2: SCR System Tampering Inducement Faults**

**Item 1:** For the first hour after a failure or tampering occurs there is a warning only, with no de-rate.

**Item 2:** Hour 1 to hour 5 there will be a 25% de-rate accompanied with fault code SPN 5246-15 AFT SCR operator inducement severity - Least severe.

**Item 3:** After 5 hours from initial awareness the vehicle will ramp to 40% de-rate and will search for the final inducement trigger accompanied with fault code SPN 5246-16 AFT SCR operator inducement severity - Moderately severe.

**Item 4:** Once final inducement is triggered the vehicle will ramp to a 5mph de-rate accompanied with fault code SPN 5246-0 AFT SCR operator inducement severity - Most severe.

**Note:** \*\*The time between stage 3 and 4 will be determined based on the fault code and triggers. If repeated tampering occurs the time window between stages will be reduced.

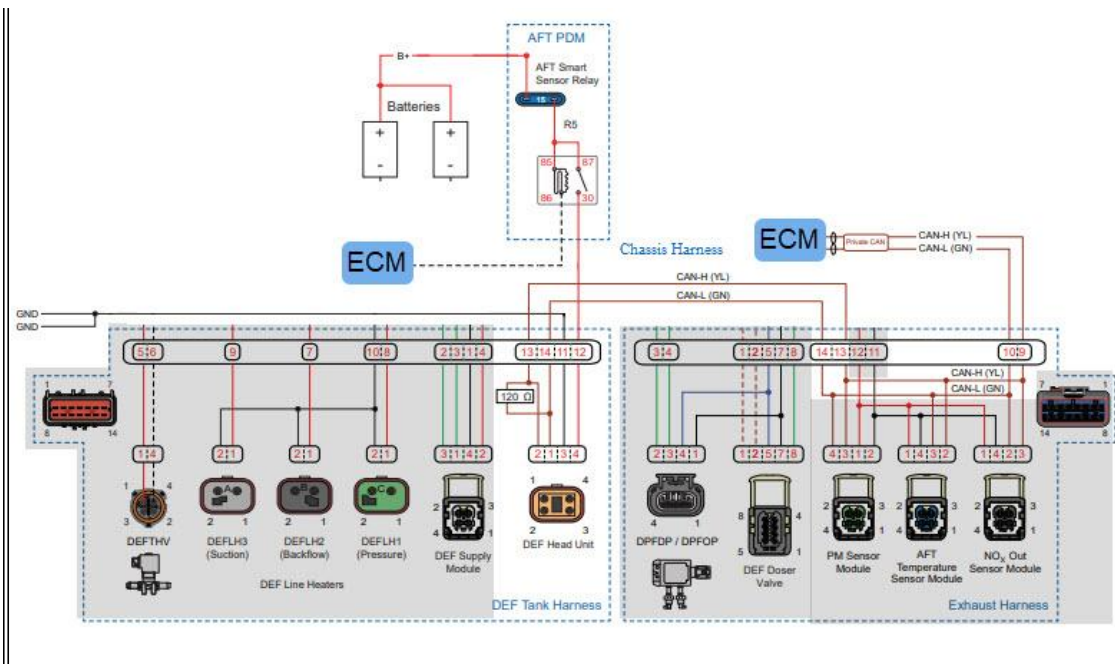
**Figure 4: General QLS Wiring Diagram**

Note: Refer to chassis circuit diagrams for detailed information

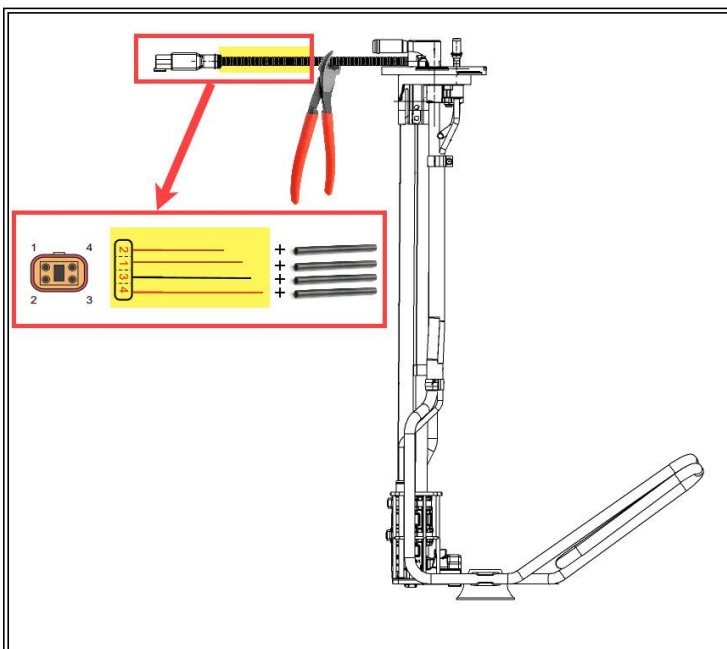
**Figure 5: QLS Pigtail Modification**

Item 1: QLS Pigtail

1. Ensure the QLS is disconnected from the chassis harness. **If the sensor is still connected it could result in shorting of the power circuit.**
2. Using wire cutters, cut the QLS pigtail harness as least four inches from the connector (Refer to figure #5). Once cut the pigtail can be moved to a bench for ease of installation.

**Note: At no point is the QLS removed from the DEF tank during this procedure.**

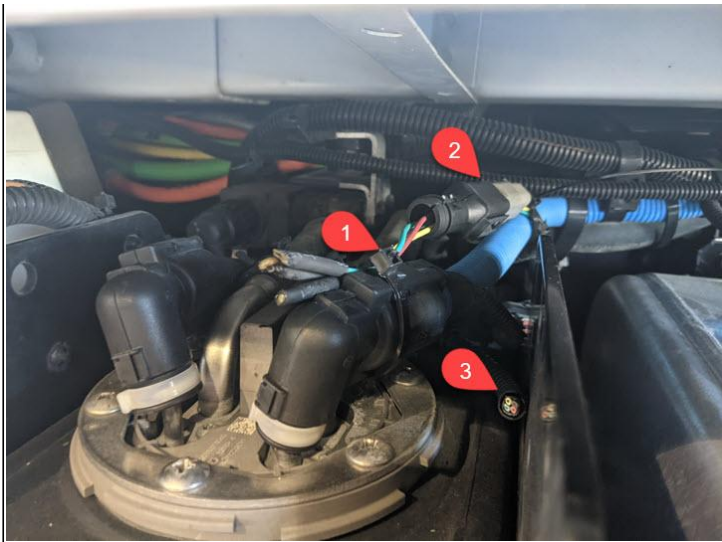
**Figure 8: QLS Pigtail Installed**

Item 1: Zip tie securing the harness  
Item 2: Pigtail connected to chassis connector  
Item 3: Harness to QLS left unsealed

8. Secure the harness using a zip tie (Refer to figure #8).
