N576NAS1

TECHNICAL BULLETIN

Service Action - Coolant Level Sensor Loose

MODEL:	MODEL YEAR:	VIN:
Defender (LE)	2020-2021	000001-025820

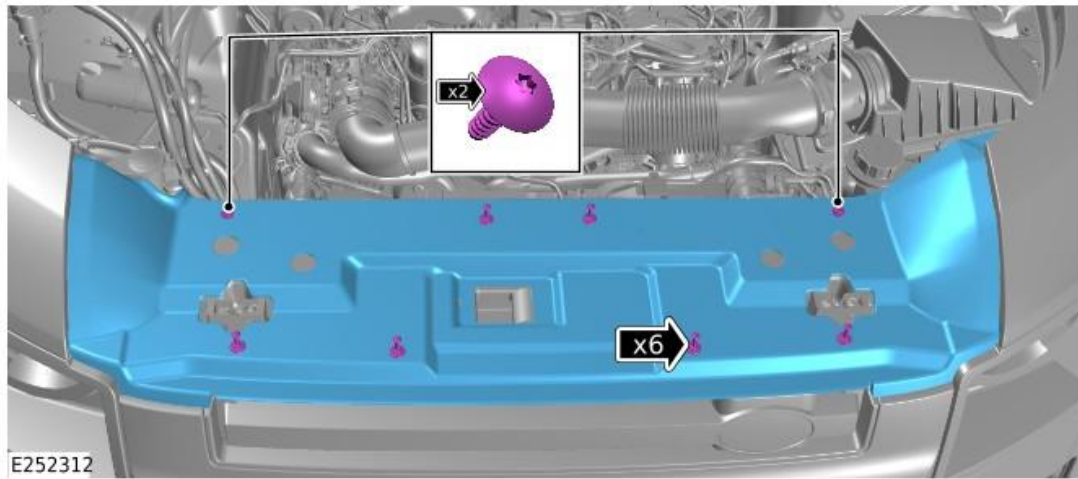
1.

Remove the upper radiator grille panel.

- Remove the 2 bolts.
 - Torque: **5 Nm**
- Remove the 6 clips.

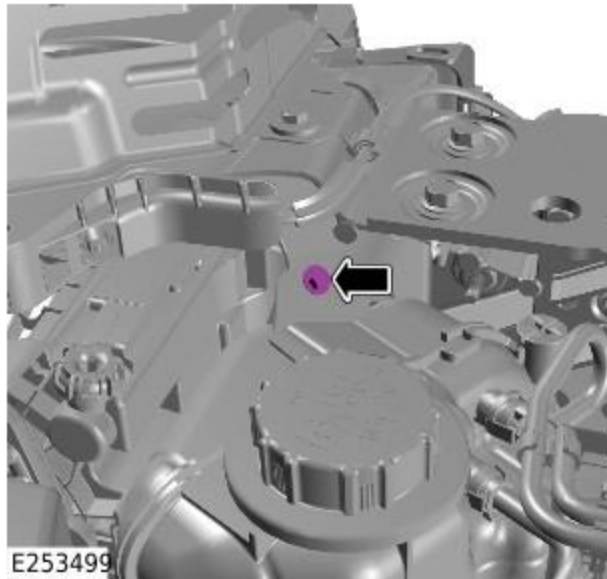
2.

Remove the bolt from the coolant expansion tank bracket.

- Torque: **2.8 Nm**

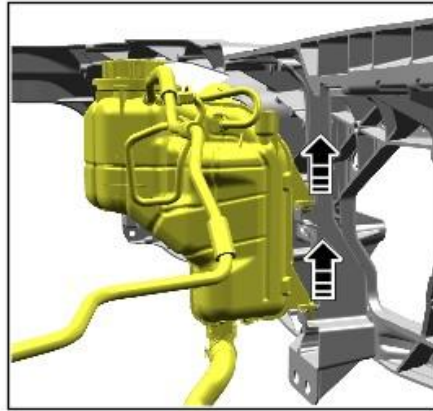
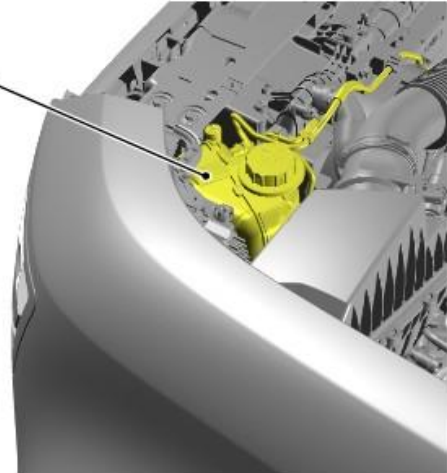
E253500

The coolant expansion tank part number is located on the opposite side of the expansion tank to the Min/Max markings.

Release the coolant expansion tank and reposition upwards so the part number is visible.

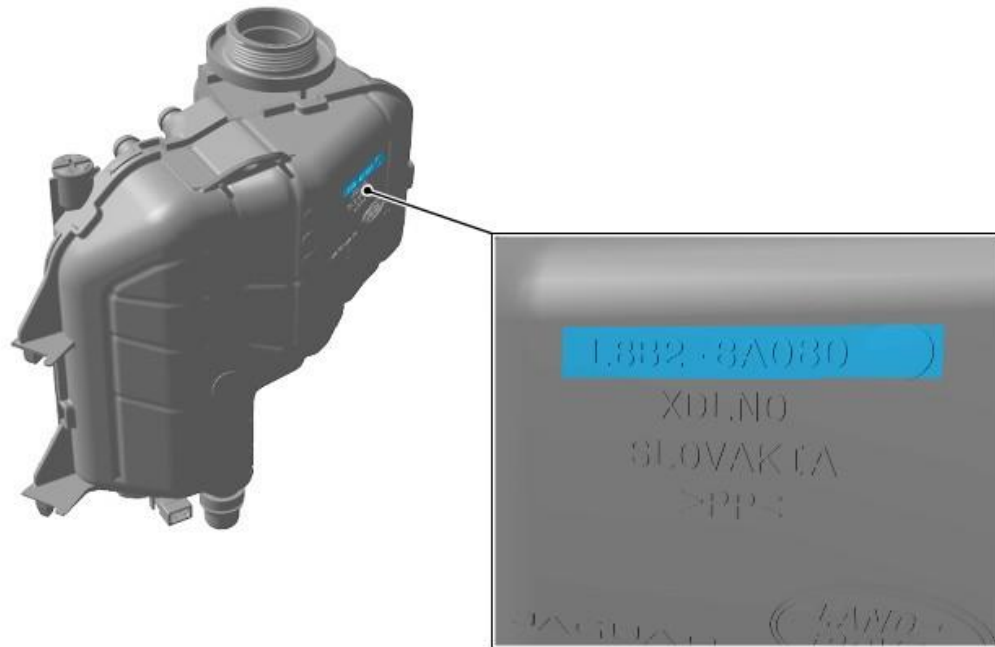
E283547

An issue has been identified on a limited number of Land Rover vehicles within the listed Affected Vehicle Range where on certain 2020 to 2021 model year Defender vehicles, a false low coolant level warning message may be displayed on the Instrument Panel Cluster Control Module (IPC), due to a loose coolant level sensor.

Inspect the coolant expansion tank part number.

- If the coolant expansion tank part number is **L8B2-8A080-AF** or **L8B2-8A080-AG**, reverse steps 1 to 3 and release the vehicle.
- If the coolant expansion tank part number is not **L8B2-8A080-AF** or **L8B2-8A080-AG**, continue to the Service Instruction.

1. Renew the coolant expansion tank (see TOPIx Workshop Manual section 303-03: Engine Cooling - Removal and Installation - Coolant Expansion Tank - **Complete removal steps 4 to 7, followed by all installation steps**).
