N636NAS1

TECHNICAL BULLETIN

Service Action - Engine to Body Ground Cable Loose

MODEL:	MODEL YEAR:	VIN:
Range Rover Velar (LY)	2021	296471-324271

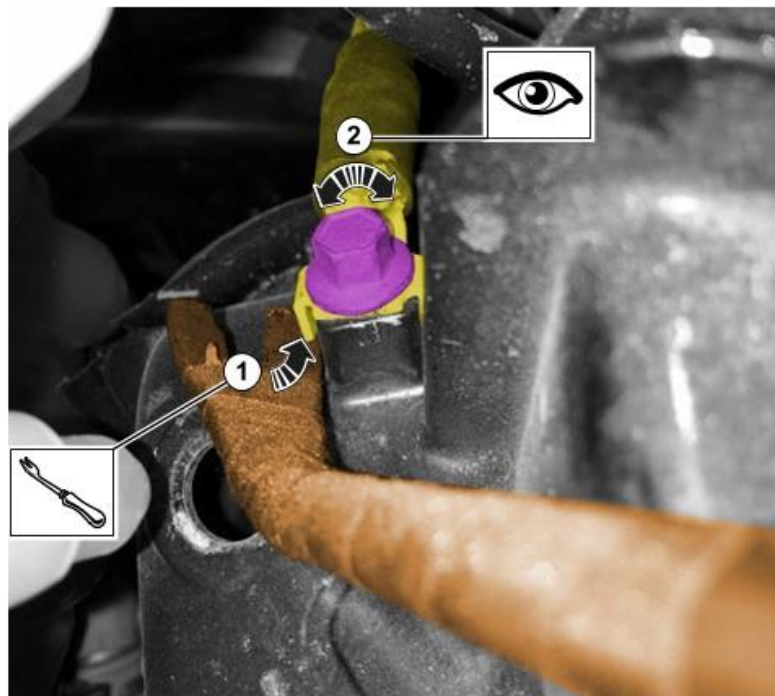
E294447

Complete the engine ground cable eyelet inspection.

1. Using a suitable tool positioned under the locating tab, try to move the engine ground cable eyelet.
2. Visually inspect the engine ground cable eyelet for movement.
 - If engine ground cable eyelet movement is visible, **continue to Service Instruction A.**
 - If engine ground cable eyelet movement is **not** visible, **continue to Service Instruction B.**
