Pre-Delivery Inspection Test Drive for Drivetrain

Models	Model Year	Model Type	VIN Range	Vehicle-Specific Equipment
Taycan	2020 - 2022	Y1ADB1, Y1AFC1, Y1AFH1	N/A	N/A

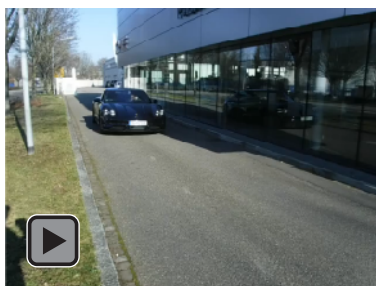
Video 1

A loud knocking noise can result from the rear drive module (transmission and electric motor) that is particularly audible when accelerating to approximately 38 mph (60 km/h). Additionally, a warning message(s) can result simultaneously in the cluster with the text, "reverse not available," and or "parking lock not available."

The damage associated with the noise described herein occurs in the transmission. This damage can already occur during low vehicle mileage.

1. If a noise and/or anomaly similar to that of the one witnessed in the video occurs, then please immediately capture the noise with both audio and video, and cease operation of the vehicle immediately thereafter. Avoid driving the vehicle further with the damaged Rear Drive Module.

- If this noise does occur, please open a PQIS entry immediately, and proceed to replace the rear drive module
