Y1A Charging Interrupts with Delta Wallbox Chargers

Models	Model Year	Model Type	VIN Range	Vehicle-Specific Equipment
Taycan	2020-2022	Y1A	N/A	N/A

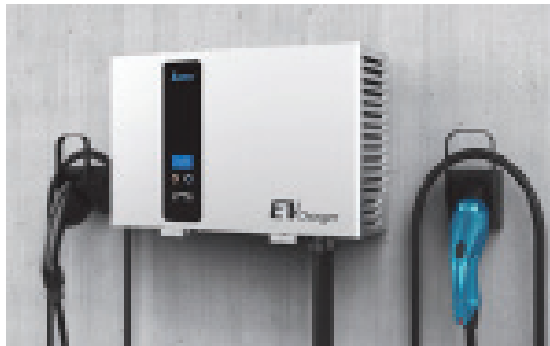
During charging sessions on Delta DC Wallbox EV Charger, interruptions may occur at different vehicle state of charge.

Due to a software issue in the Delta DC Wallbox EV Charger, a communication request from the vehicle may not correctly be answered by the charger. This may result in the vehicle ending the charging process prior to reaching the desired state of charge.

If a Taycan experiences an interrupted charging session on a Delta DC Wallbox EV Charger, the charging session may be manually restarted. No repairs on a Taycan should be attempted at this time.

Delta has developed a firmware update for the Delta DC Wallbox EV Charger that resolves this issue.
