Technical product information

| Topic | Driver/Passenger door/s creak on close |

Bentayga

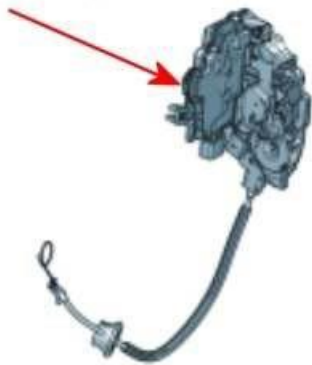
Figure 1

Refer to the vehicle repair history to check/confirm if any previous work which has been conducted regarding door latch replacement (Figure 1)

In the event the door latch date of manufacture is unknown (No notes within the vehicle repair history) the date of manufacture of each door latch must be confirmed

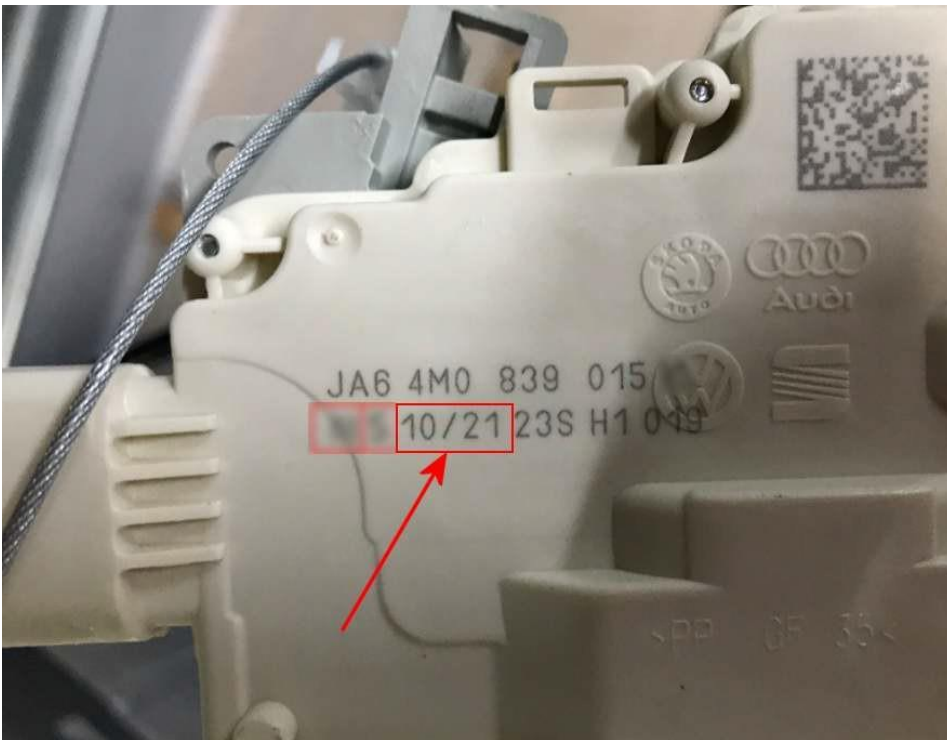
- 1) Referring to the applicable Rep.Gr - Remove the front and rear door trims
- 2) Referring to Figure 2 - Check the date of manufacture in the location shown

[Latch manufacturing date code prior to 10/21](#)

[Latch manufacturing date code post 10/21 or 22 Model year](#)

- Referring to the applicable Repair Group - Replace all latch motors to latest specification

- Referring to the applicable Repair Group - Replace the faulty door latch only
