**P1C9500 Faults causing the Instrument Cluster Warning “Transmission failure – Park vehicle safely” and Immobility**

Models	Model Year	Model Type	VIN Range	Vehicle-Specific Equipment
Taycan	2020 - 2022	Y1ADB1, Y1AFC1, Y1AFH1	N/A	N/A

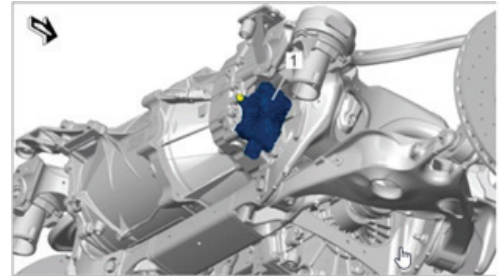
An initialization issue in the control unit for the servomotor causing this fault is resolved in a pending VR software release.

**Figure 1 - ETSM (1)**

**Location on Transmission**

1. Switch off ignition
2. Pull electric plug from the electronic transmission servo motor (ETSM) -> ETSM is marked blue in Figure 1
3. Please wait 60 seconds
4. Put electric plug back on the ETSM
5. Turn ignition on
6. Please wait 60 seconds
7. Switch off ignition
8. Repeat Step 5-7
9. Clear fault memory
