# McLaren Elva – Door Gas Strut Mounting Point Application of Bonded Brace

**Bulletin type:** Service Campaign  
**Campaign reference:** SCB 26 A 002  
**Attention:** Retailer Service Managers, Retailer Service Advisors and Retailer Technicians  
**Affected vehicles:** McLaren Elva  
**Situation:** Preventative action for the door gas strut mounting point  
**Procedure:** Action affected vehicles on the next Retailer visit  
**Date:** 14<sup>th</sup> October 2021

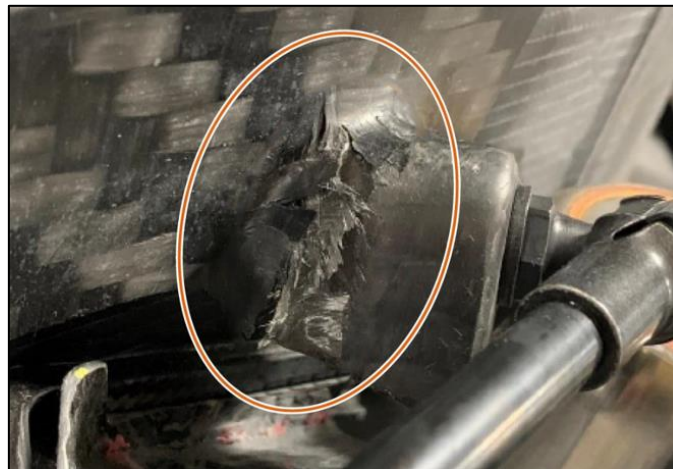
Upon inspection of the gas strut mounting point, should you find a substrate failure, perform the required work as outlined in document SCB 26 A 002 WI-2 (Countermeasure Rework) also attached to this Bulletin.

Example of substrate failure
