Key Programs More Readily When Placed Directly on Transmitter

Models	Model Year	Model Type	VIN Range	Vehicle-Specific Equipment
Taycan	2020 - 2022	Y1A	N/A	N/A

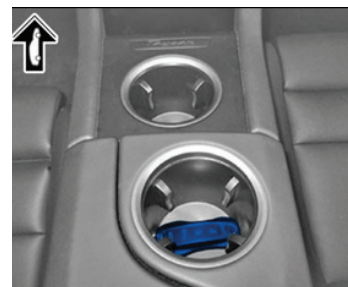
Figure 1

After many attempts, key programming is not successful for one or more keys. The workshop may observe this condition while performing WKK8.

In cases where the workshop experiences this condition, programming is often successful after placing the key in direct contact communication device (found under the cup holder) instead of in the emergency start tray. (the key reading location found in the cup holder – see figure 1).
