Y1A Taycan - Thermally and noise insulated rear window glass cracked

Vehicles Affected

Models	Model Year	Model Type	VIN Range	Vehicle-Specific Equipment
Taycan	As of 2020 up to 2022	Y1AAA1, Y1ADB1, Y1AFC1, Y1AFH1	N/A	N/A

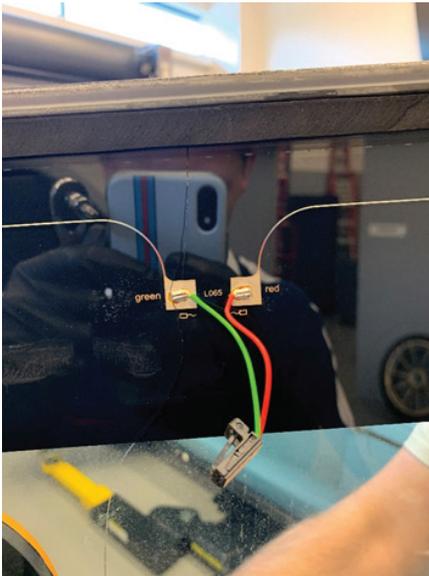
1. Soldering points at the top of the inside of the glass

The crack is a stress crack that begins at one of the two soldering points at the top of the inside of the glass, and propagates towards the lower part of the rear window.

Figure 1: Crack at the soldering points

Note: The crack can be found at either soldering point (red or green).

To resolve this issue, please replace the rear window glass as instructed in *Workshop Manual WM 648619 – Removing and installing rear window.*

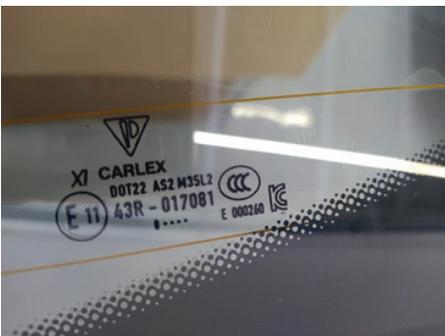
2. Manufacturing stamp at the lower right corner of the outside of the glass

Figure 2: Manufacturing stamp

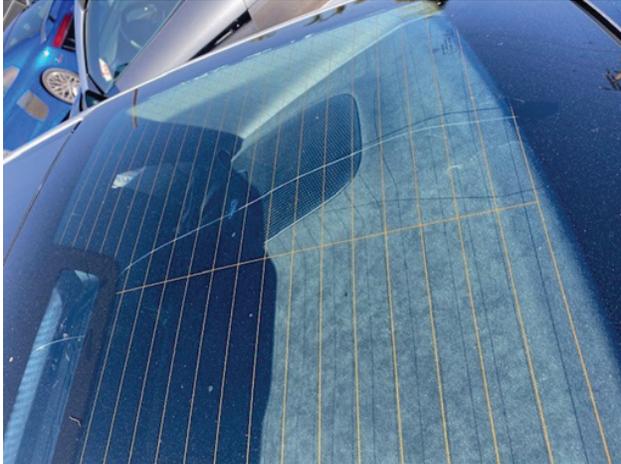
3. Overview of the rear window that clearly displays the crack

A crack can be seen on the inside surface of the rear window extending from the third brake light down to the bottom of the rear window glass. This condition is often noticed during the PDI.

Figure 3: Rear window overview
