## Mack Chassis - Anthem (AN) Water Leak Around Door

Mack Anthem models may experience water intrusion through the door seal. The likely source of intrusion can be found in the area around the bottom of the A pillar trim panel.

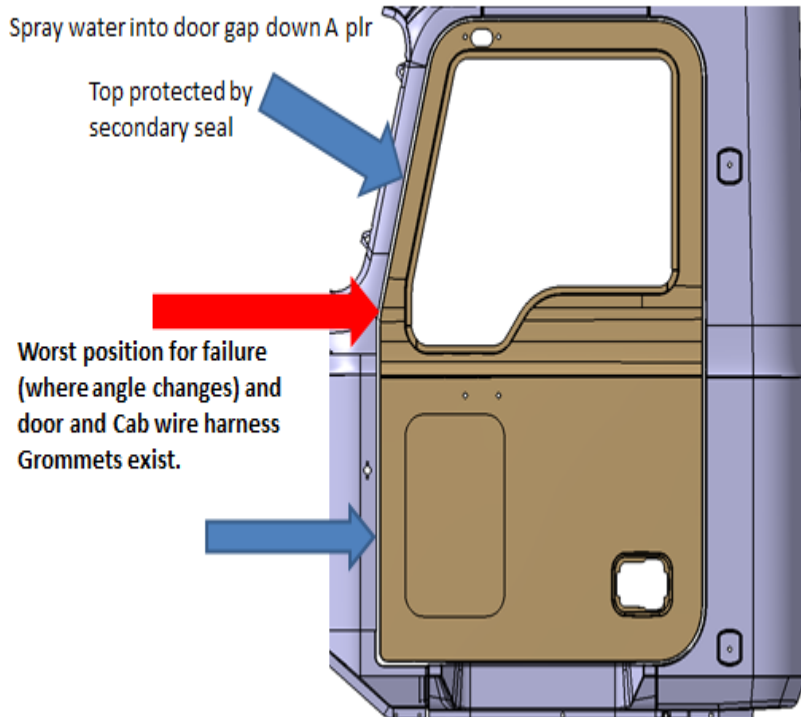
#### Door seal water test evaluation

Spray water into door gap down A pillar
