## Service Campaign S7610

# Bump Stop Relocation

Years	Models
2020 - 2021	GR, LR, TE

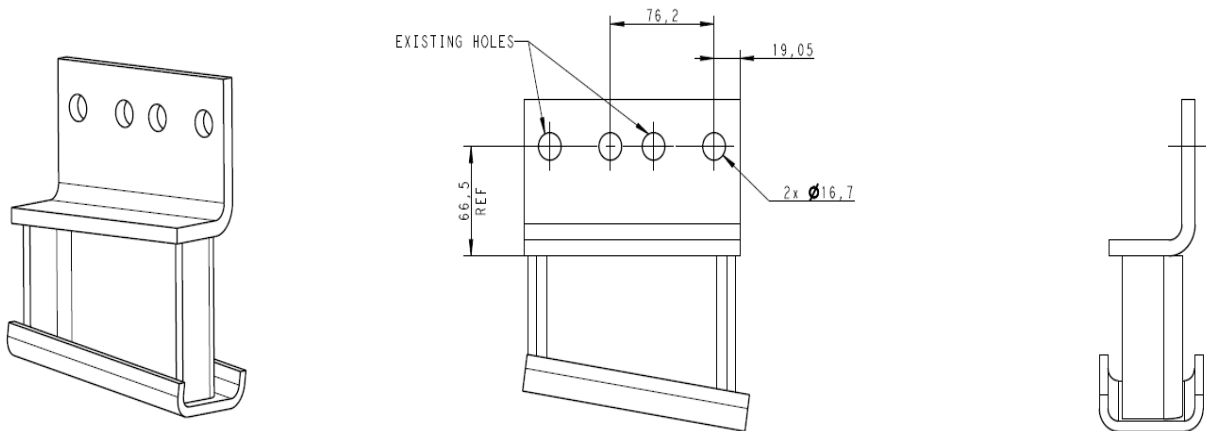
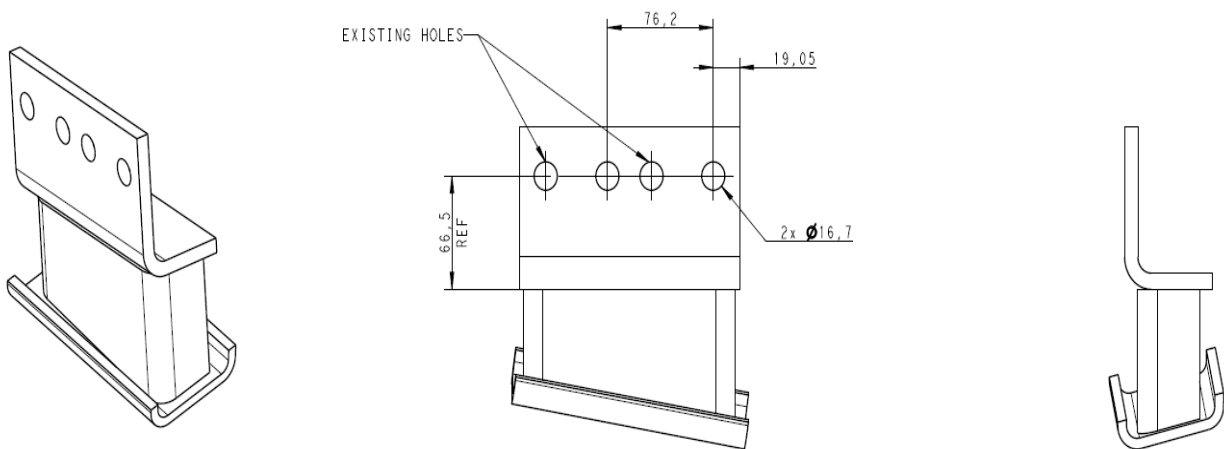
Some Mack trucks built with Hendrickson Haulmaax® suspension and high mount brakes on the rear most axle, may experience a lack of clearance between the suspension bump stop and the slack adjuster. To correct this possible issue the bump stops will need to be removed, re-drilled, and reinstalled using the new hole locations. This will require replacement of the bump stop fasteners.

1. Secure vehicle for service.
2. Remove the rearmost left and right suspension bump stops.
3. Inspect slack adjusters for any damage. If damage is found replace the damaged slack adjuster. Refer to IMPACT for correct part numbers and procedure.
4. Using supplied location drawing (page 3), locate and drill new holes in the removed bump stops.
5. Install re-worked bump stops and new fasteners using the newly drilled holes.
6. Torque bump stop fasteners to  $275 \pm 45$  Nm ( $203 \pm 33$  lbf-ft).
7. Release vehicle to service.

Measurements shown in millimeters.
