992 Poor Ground Leads to Starting Issue

Models	Model Year	Model Type	VIN Range	Vehicle-Specific Equipment
911 Carrera	As of 2020 up to 2021	992	N/A	N/A

Revision	Release Date	Changes
0	October 26, 2021	Original document

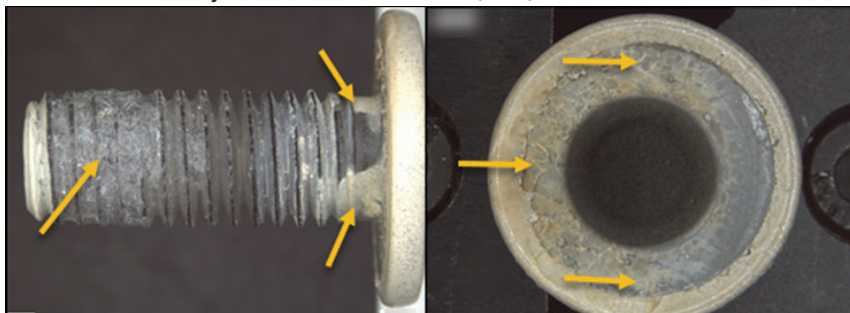
- a. More likely – Paint contamination and corrosion of the ground bolt or ground strap. Arcing exacerbates this corrosion. (See figures 1 and 2.)
- b. Less likely – A loose ground bolt. Sometimes the factory has not sufficiently tightened this bolt.
- c. Less likely – A defective starter (rare).

Figure 1 - Ground bolt with paint contamination. (Before arcing has occurred.)

- Check for good electrical connectivity at the ground strap and bolt. Perform a voltage drop before removing it.
- Be sure to thoroughly brush and clean away all paint contamination from the ground strap and bolt. Use special tool VAS 6410 - Contact Surface Cleaning Set. Find tool information here: <https://porsche.snapon.com/special-tools-detail.aspx?itemId=21520163>
- Be sure to correctly tighten the ground bolt.

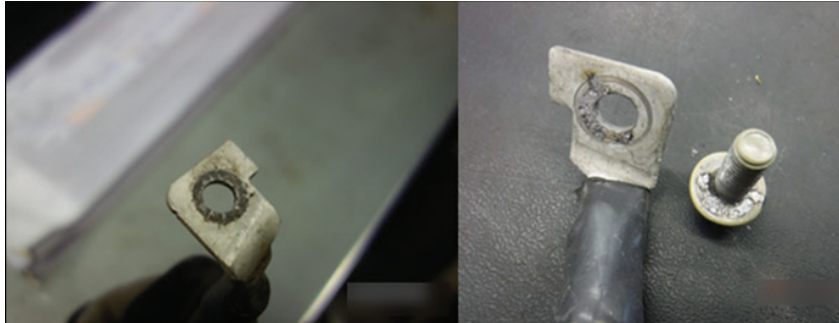
**Figure 2 - Ground strap and bolt after arcing occurs. (Corrosion has increased).
These parts are from a vehicle that would not start.**
