## Technical product information

<b>Topic</b>	V8 Kovomo - Engine misfires - Engine management light illuminated within the DIP
<b>Market area</b>	Russische Föderation (5RU),Australia E04 Bentley rest Asia and Australia (6E04),China 796 VW Import Comp. Ltd (Vico), Beijing (6796),Germany E02 Bentley rest Europe (6E02),Japan E03 Bentley Japan (6E03),Korea, (South) E08 Bentley South Korea (6E08),United Arab Emirates E06 Bentley Middle East and Africa (6E06),United Kingdom E01 Bentley UK (6E01),United States E05 Bentley USA and rest America (6E05)
<b>Brand</b>	Bentley
<b>Transaction No.</b>	2064776/1
<b>Level</b>	EH
<b>Status</b>	Approval
<b>Release date</b>

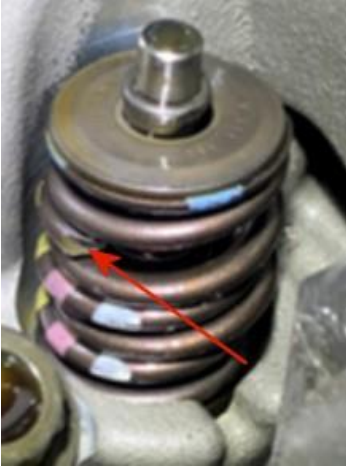
VERY IMPORTANT: Ensure the photos show the location in which the valve spring(s) is broken (ARROW) the various paint markings should also be captured within the photos

- Remove the affected cylinder head
- Referring to Figure 1 - Take clear photos of the broken valve spring (from the affected cylinder only)
