Technical product information

Topic	Knocking noise from the front and/or rear (Driving over an uneven road surface)
Market area	Russische Föderation (5RU),Australia E04 Bentley rest Asia and Australia (6E04),China 796 VW Import Comp. Ltd (Vico), Beijing (6796),Germany E02 Bentley rest Europe (6E02),Japan E03 Bentley Japan (6E03),Korea, (South) E08 Bentley South Korea (6E08),United Arab Emirates E06 Bentley Middle East and Africa (6E06),United Kingdom E01 Bentley UK (6E01),United States E05 Bentley USA and rest America (6E05)
Brand	Bentley
Transaction No.	2064791/1
Level	EH
Status	Approval
Release date

New Continental GT/GTC and New Flying Spur

Knocking noise from the underside of the vehicle (front and/or rear) when driving on uneven road surfaces

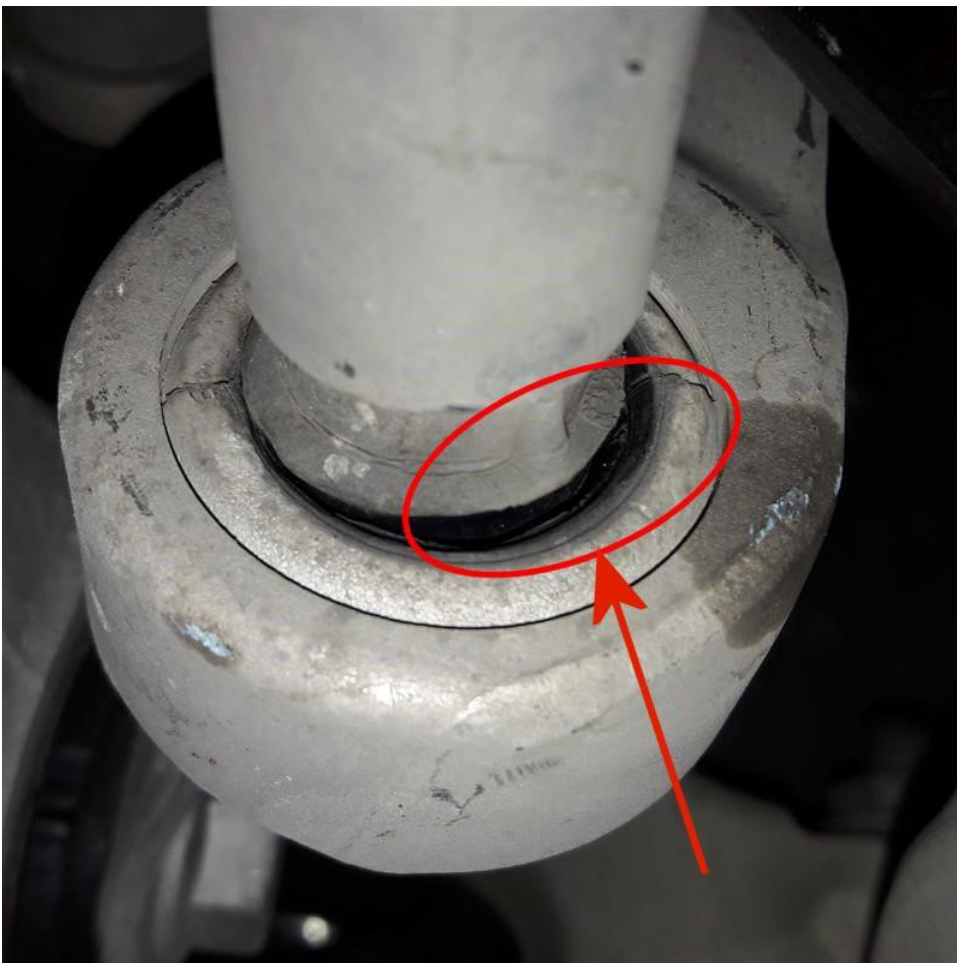
Figure 1

The noise present in the sound file can be caused by worn anti roll bar bushes, the noise can appear when driving over an uneven road surface or during a large suspension input for example:

- Worn front and/or rear anti-roll bar drop link bushes (Figure 1)

5) Referring to the applicable Rep. Gr - Replace the left and right drop links (front and/or rear)

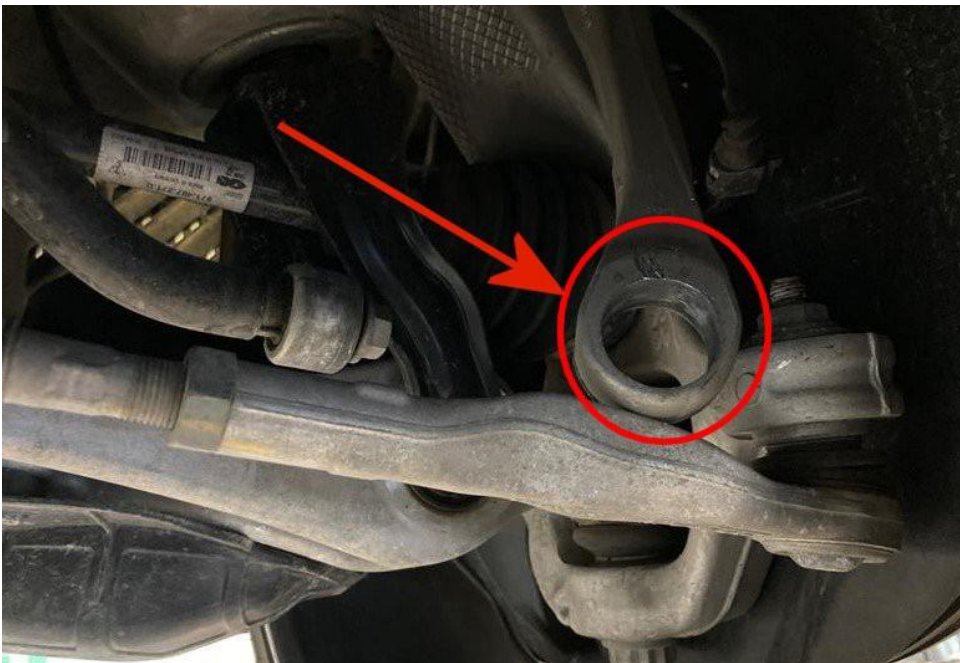
Figure 2

2) Check the front and/or rear anti roll bar drop link has not detached (Figure 2) in this scenario DTC (C1298F1: Suspension stabilization actuator Regulation not possible) may also be evident within address D4 and/or D5
