Technical product information

Topic	Knock/clunk noise from the rear of the vehicle (Rear axle)
Market area	Russische Föderation (5RU),Australia E04 Bentley rest Asia and Australia (6E04),China 796 VW Import Comp. Ltd (Vico), Beijing (6796),Germany E02 Bentley rest Europe (6E02),Japan E03 Bentley Japan (6E03),Korea, (South) E08 Bentley South Korea (6E08),United Arab Emirates E06 Bentley Middle East and Africa (6E06),United Kingdom E01 Bentley UK (6E01),United States E05 Bentley USA and rest America (6E05)
Brand	Bentley
Transaction No.	2064477/3
Level	EH
Status	Approval
Release date

Knock/clunk noise from the rear of the vehicle (Rear axle)

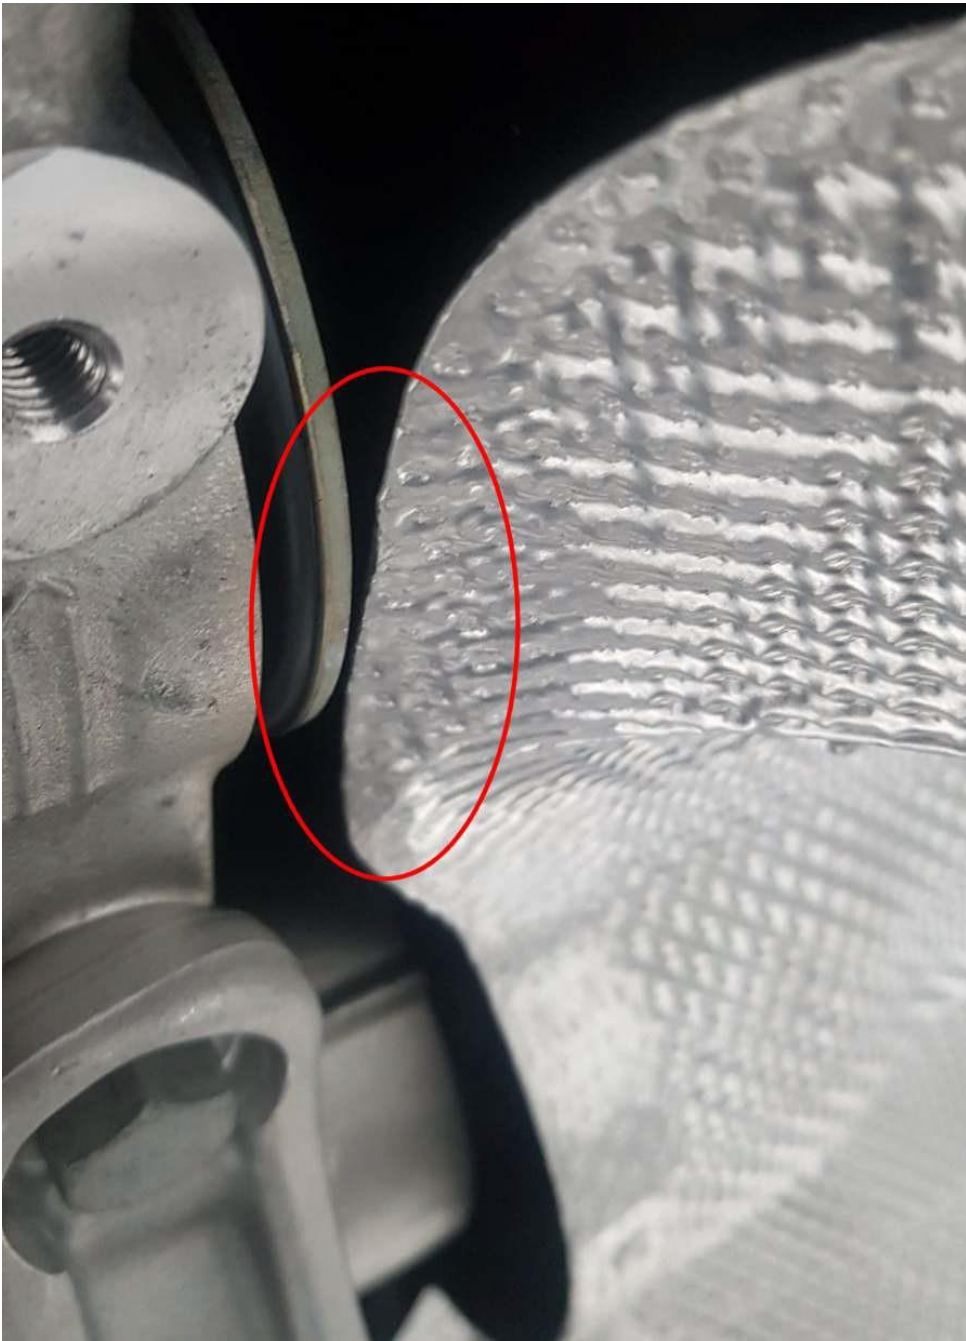
Figure 1

3) Referring to Figures 1 and 2

- Check to confirm the heat shields are not in contact or have witness marks showing evidence of contact with the rear differential and/or surrounding components

▪
NOTE: In the event the issue shown regarding the heatshield is evident, the operative should rectify (relocate the heatshield) and retest

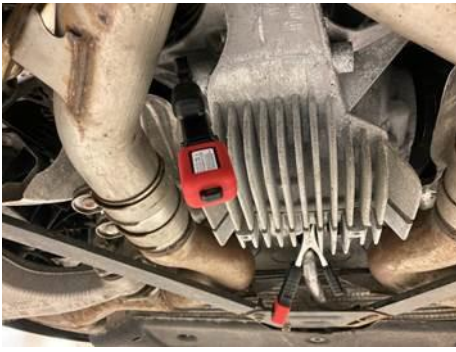
Figure 1

- Use WT 10437 (Chassis Ear Tool) to identify the source of problem by attaching the clamp and module assemblies to the areas of concern. For example, front and rear of the differential casing, as well as the upper control arms on the suspension (see Figures 1 to 3 for examples)
