Technical product information

Topic	DTC's P014800 and/or P008A00 - Rough running & potentially poor start up performance - MIL light on - Possible misfires
Market area	Russische Föderation (5RU),Australia E04 Bentley rest Asia and Australia (6E04),China 796 VW Import Comp. Ltd (Vico), Beijing (6796),Germany E02 Bentley rest Europe (6E02),Japan E03 Bentley Japan (6E03),Korea, (South) E08 Bentley South Korea (6E08),United Arab Emirates E06 Bentley Middle East and Africa (6E06),United Kingdom E01 Bentley UK (6E01),United States E05 Bentley USA and rest America (6E05)
Brand	Bentley
Transaction No.	2062016/2
Level	EH
Status	Approval
Release date

New Continental GT/GTC and New Flying Spur - W12 TSI only

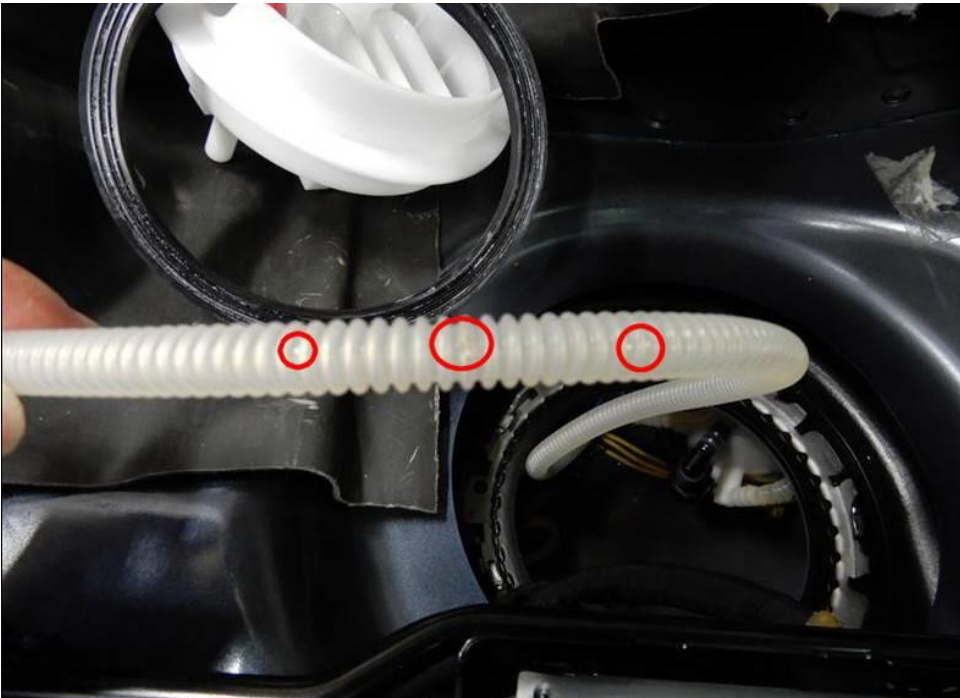
Debris in the fuel system can lead to a blockage in the low pressure fuel injectors, ultimately causing a cylinder misfire.

- Inspect the Fuel supply module and fuel filter fitment for detached hoses, damaged hoses and line and/or concerns with the module itself such as damage or leakage
- Figure 1 shows an example of a fuel tank internal hose with pin holes (circled)

9. Should any of the afore mentioned issues be evident the required parts should be replace as necessary

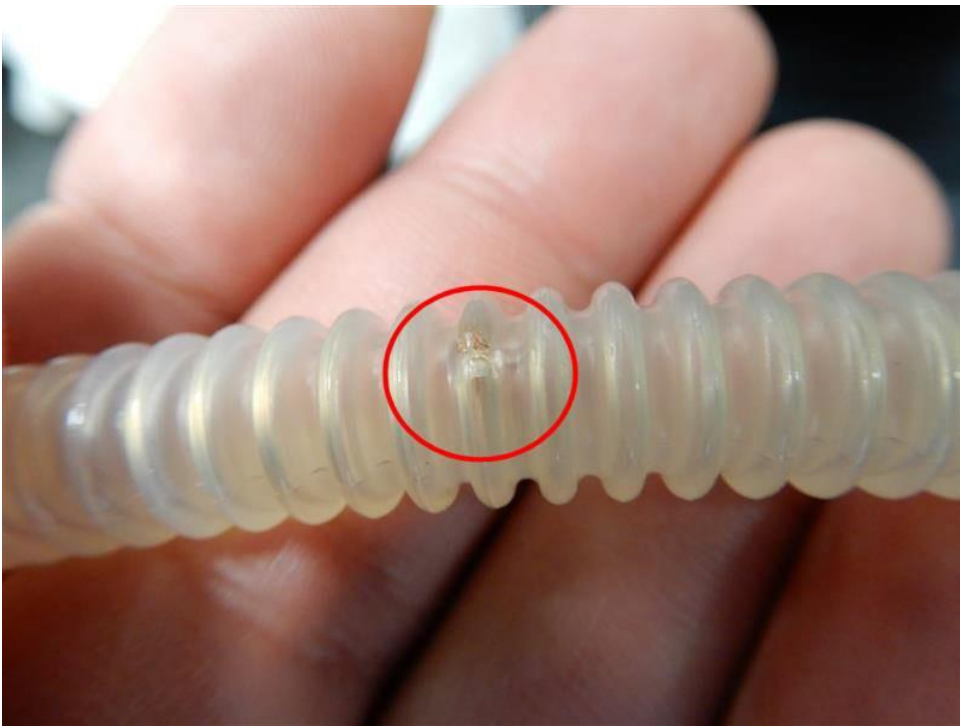
- Figure 2 shows a close up of the pin holes
