Taycan: Clicking Noises from Carbon Fiber Aeroblade Wheels

Models	Model Year	Model Type	VIN Range	Vehicle-Specific Equipment
Taycan	As of 2020	Y1A	N/A	44I – 21" Taycan Exclusive Design Wheels with Carbon Fiber Aeroblades

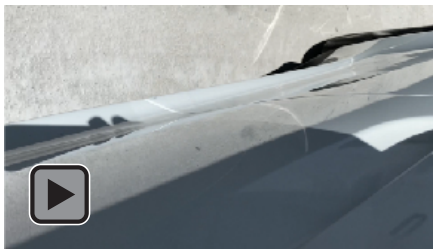
Figure 1 - Sound File

The customer complains of clicking noises from the wheels while maneuvering at slow speeds. The clicking noises can be traced back to the contact points between the carbon fiber aeroblade inserts and the 21" alloy wheel.
