Symptom in Vehicle Interior – Seat Backrest Release Stiff or Actuating Lever (Loop) Torn: Checking and Replacing Backrest Frame (SY 121/21)

Model Line: **911 (992)**

Model Year: **As of 2020 up to 2021**

Concerns: **Front-seat backrest frame**

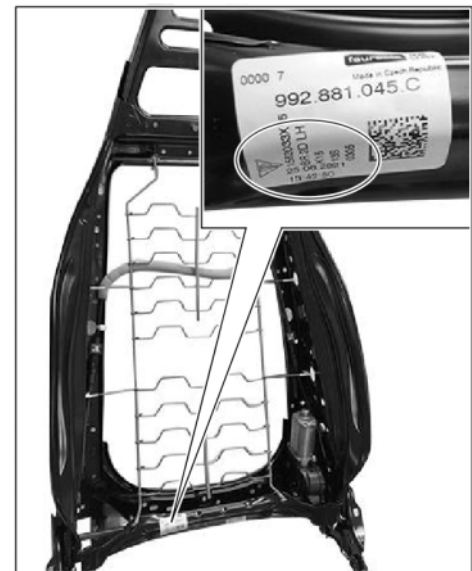
Production date of backrest frame

The new backrest frames can be identified by the production date. Backrest frames produced from June 18, 2021 have already been optimized.

- Check the production date of the **new** backrest frame. ⇒ *Production date of backrest frame*
- Replace backrest frame. ⇒ *Workshop Manual '721955 Replacing backrest frame'*
