Valve Cover Oil Leak at T Joint
CHU, CXU, GU, PI, AN, GR

FSB 211-003, Valve Cover Oil Leak at T Joint

(October 2021)

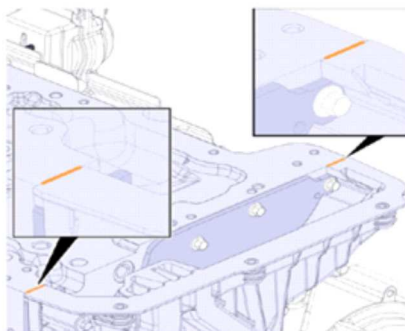
T2176113

New Seal Pattern

- The lower valve cover frame gasket is NOT to be reused. Always replace the gasket anytime the lower valve cover frame is disturbed (i.e. removed).
- Before applying sealant **BE SURE** the surface is **completely** free of grease, oil, and old sealant. Any oily or greasy residue will prevent the sealant from properly adhering. The use of a cleaning agent/solvent will be required (i.e. Brake-Clean or equivalent).
- When applying the sealant follow the procedure in IMPACT. Use 2 beads of sealant per side at a thickness **no larger than** 2mm (.078 in). See image below. In this joint, too much sealant causes issues.
- Install the lower frame with new gasket, upper valve cover, and torque to specification within 20 minutes of sealant application.

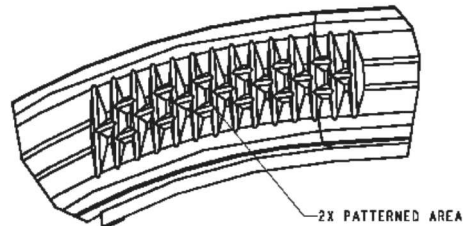
T2176114

Old Seal Pattern

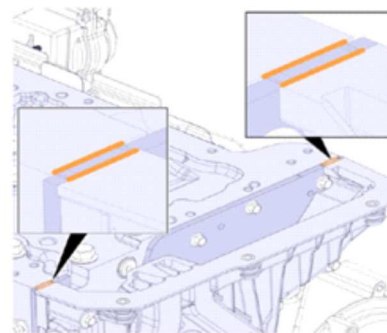
T2176116

MP8 Integrated Seal Timing Gear Plate
