Automated Manual Transmission Gearbox Will Not Shift To High Range After Gearbox Repair; MID 130 PSID 24 FMI 1, P1072-92 Unintentional Disengagement Of High Range - US07 And Newer Emissions, Model Year 2008 And Newer

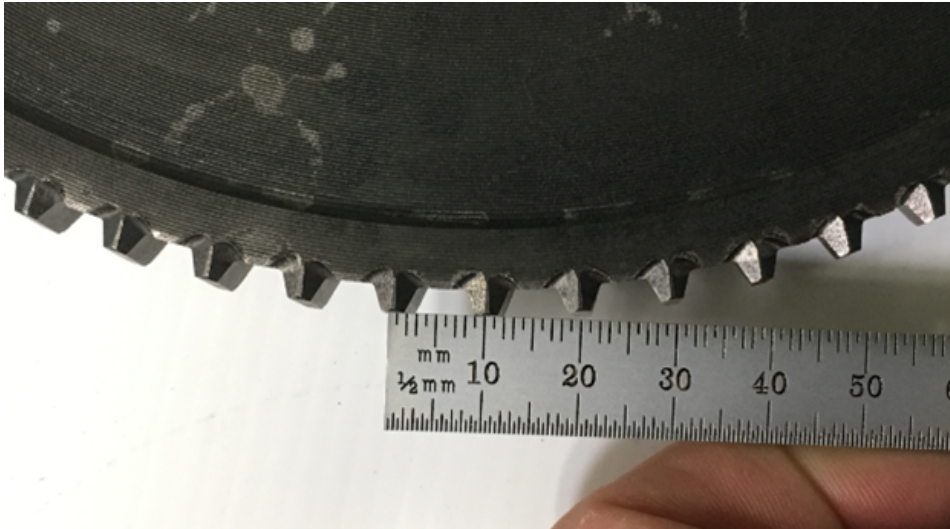
The correct tooth spacing is approximately 10 millimeters from the center of each tooth on the high range synchronizer center hub.

Inspection of the tooth spacing for the components prior to installation will eliminate any potential mismatch of components and extended diagnostic time resulting from the incorrect components.

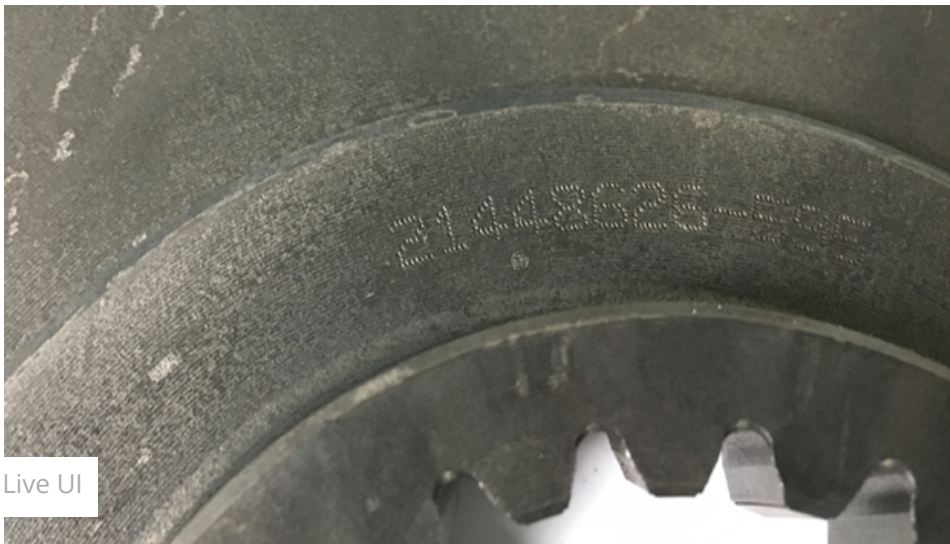
The Part Number for the correct center hub is 21448626.

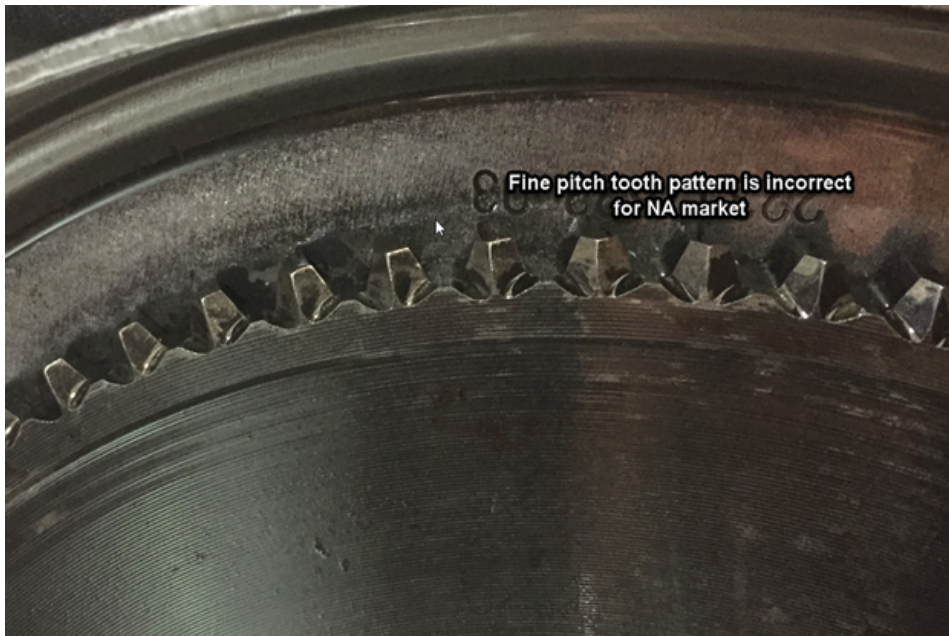
The incorrect fine tooth hubs have a Part Number of 21753650.

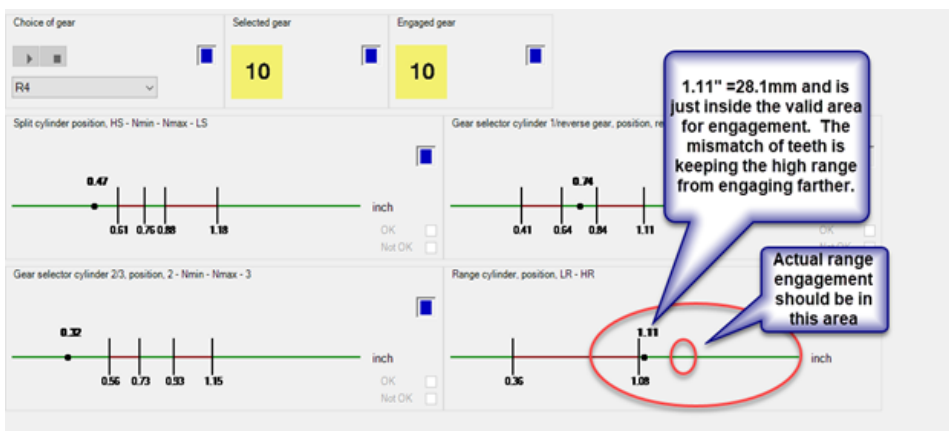
What you will see in Tech tool if the unit gets assembled this way.

Reviewing the Gears Test (4311-08-04-01) , calibration values (4320-07-03-01) or the Range Solenoid Test (4320-08-03-02) screens, the high range engagement will show to be barely within the valid calibration/engagement area. The teeth will mesh just enough to allow a good calibration and test results however the teeth are not engaged and the torque applied to the unit will force the range out of gear.

The average high range engaged position is 33 mm (1.31 inches) range.
