Forward Looking Radar Shortage – Plug Inspection

Years	Models
2022	AN, PI

Introduction

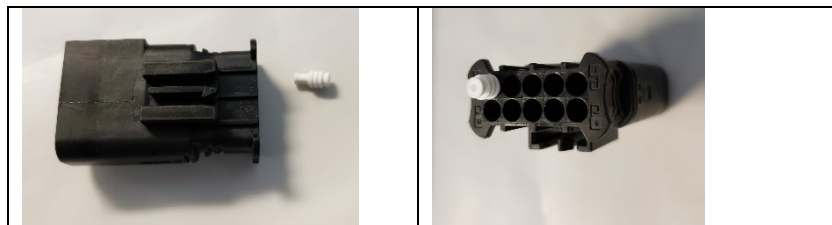
Mack Trucks has determined that a certain number of trucks shipped-short without the forward looking radar may not have received proper installation of the electrical connectors/cap that protects the electrical harness. To ensure that the electrical harness is properly sealed off and protected for the elements follow the repair below to inspect the connector.

1. Secure the vehicle for service.
2. Inspect forward looking radar electrical connector/cap for proper installation.
 - a. If the electrical cap is missing, adequately clean the wiring harness side connector and spray with anti-corrosion chemical. Order new connector/cap and wire plugs. Proceed to step 3.
 - b. If the electrical cap is installed, procedure to step 3 to inspect & configure the cap.
3. Make sure the cap (P/N 24202558) is configured correctly.
 - a. Ensure that 10 wire plugs (P/N 22036053) are inserted into the back of the connector.
