Diagnostic Trouble Code (DTC) P215A-64, Fault Code SPN 84 FMI 19

This condition may be caused by a missing or dislodged output shaft bearing snap ring, which results in a damaged transmission speed sensor.

43903-2 Seal, Output Shaft, Replacement

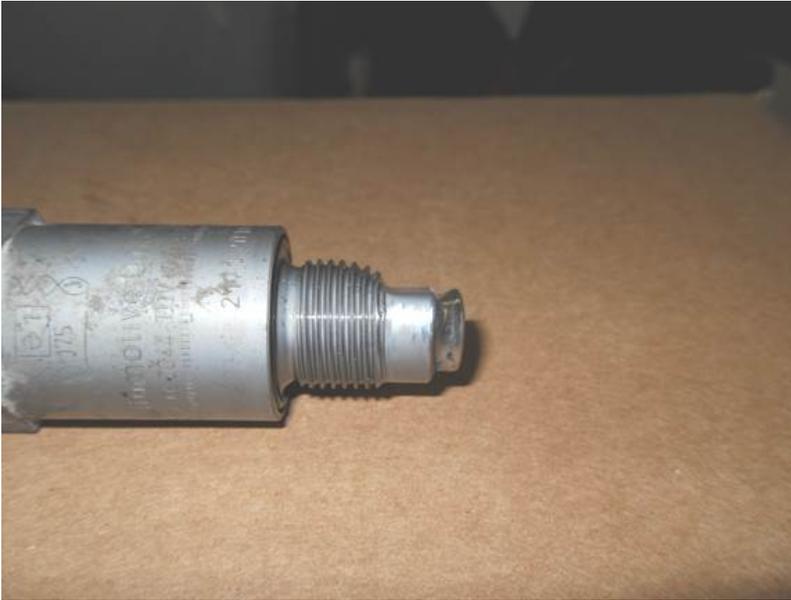
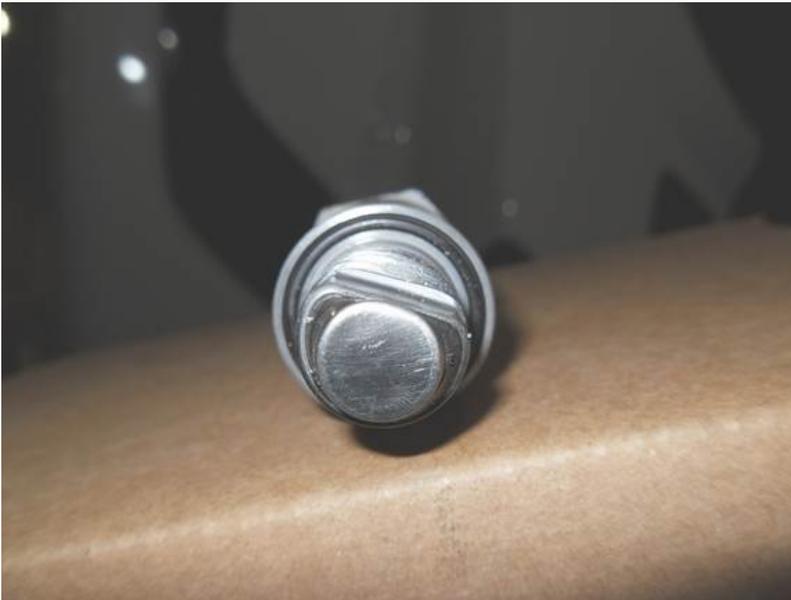
During replacement of the sensor for SPN 84 FMI 19, if the technician finds the sensor damaged in this manner (see below) the snap ring for the tail shaft bearing is missing or not seated. This repair can be done in the field.

- There are 4 different thickness snap rings:

- 1652802, THK 3.70

- 1652803, THK 3.80

- 1652804, THK 3.90

- 914556, THK 4.00

- Follow instructions for R&R the output shaft seal, 4349-03-02-03 Sealing Ring, Rear Output Shaft, Replacement.
- Reposition the tail shaft bearing forward in the auxiliary housing.
- To find the correct size snap ring start with the thickest and use the largest one that fully seats in the groove.
- Reassemble
