Technical product information

Topic	Bentayga - DTC C11C613 - Air suspension warning displayed in Driver Instrument Panel
Market area	Russische Föderation (5RU),Australia E04 Bentley rest Asia and Australia (6E04),China 796 VW Import Comp. Ltd (Vico), Beijing (6796),Germany E02 Bentley rest Europe (6E02),Japan E03 Bentley Japan (6E03),Korea, (South) E08 Bentley South Korea (6E08),United Arab Emirates E06 Bentley Middle East and Africa (6E06),United Kingdom E01 Bentley UK (6E01),United States E05 Bentley USA and rest America (6E05)
Brand	Bentley
Transaction No.	2064579/1
Level	EH
Status	Approval
Release date

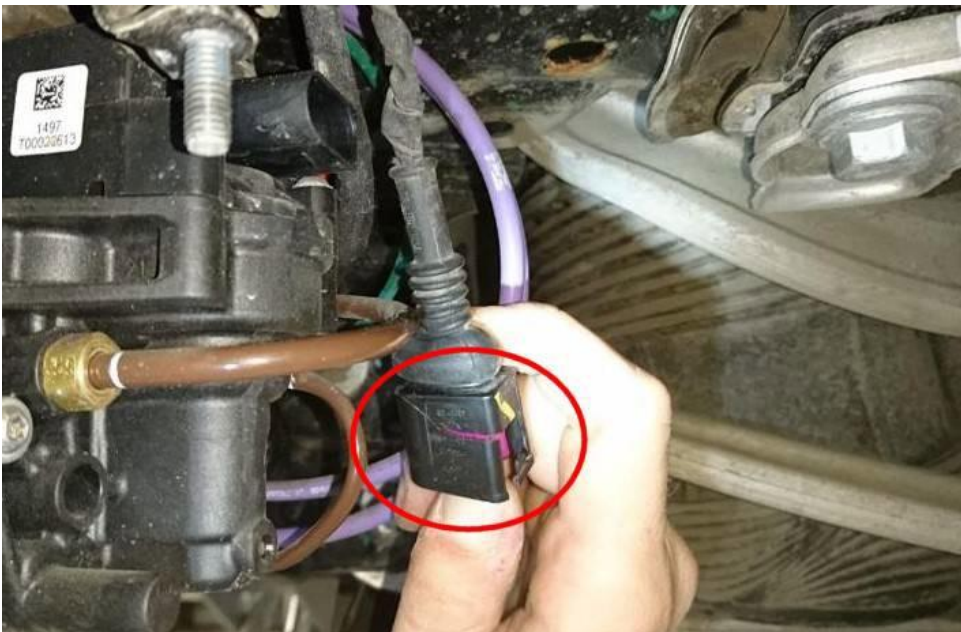
Figure 1

DTC C11C613 (Symptom Code 3145826) - Valve for rapid filling of air suspension Open circuit stored in the Chassis control unit (Address 74)

- Damage to the connector (Figure 1) - Replace connector as per all applicable Rep.Gr guidelines
- Wiring damage (Figure 2) - Repair wiring as per all applicable Rep.Gr guidelines
