Technical Service Bulletin

Topic	Seat Belt Presenter - Intermittent Operation
Market area	Bentley: worldwide (2WBE)
Brand	Bentley
Transaction No.	2034323/5
Level	EH
Status	Released for publishing

Front seat belt system presenter intermittent in operation

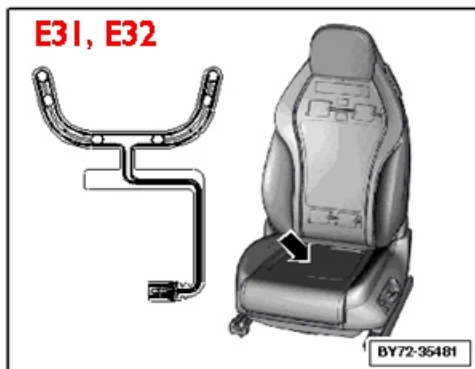
Figure 1

3. First check the occupancy sensor, E31, is function correctly (see Figure 1)

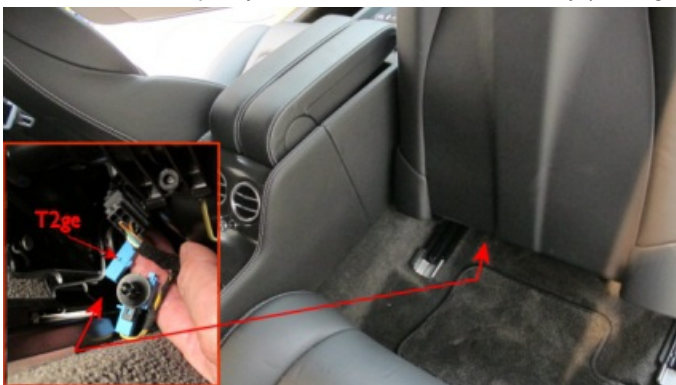
Figure 2

- Disconnect connector T2ge at the occupancy sensor (E31 Drivers, E32 Passengers). The 2 way connection can be identified by its blue connector housing located under the seat frame adjacent to the inboard seat runner (see Figure 2)

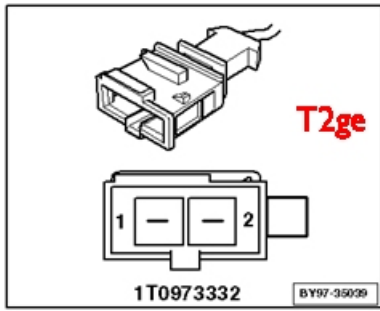
Figure 3

- With T2ge connector disconnected and an occupant sat in a natural position on the seat, with their back against the backrest, measure the resistance through the occupancy sensor (see Figure 3)

- If the resistance of the sensor with the seat occupied is greater than 90 Ohms then the sensor is faulty and should be replaced
- Once the occupancy sensor is known to function to specification (operation 2) then remove and discard the original seat adjustment control unit with memory (J136 Drivers, J521 passengers) and replace with the latest level part (part number 4W0.959.760)
 - The J136, J521 seat control unit is located under the seat frame reference workshop manual Rep. Gr.72 Front seat control unit (J136,J521) – To remove and fit
