<b>HYUNDAI</b> <b>Technical Service Bulletin</b>	<b>GROUP</b> <b>AUTOMATIC TRANSMISSION</b>	<b>NUMBER</b> <b>21-AT-017H</b>
	<b>DATE</b> <b>OCTOBER, 2021</b>	<b>MODEL</b> <b>SONATA (DN8A)</b> <b>SANTA FE (TMA)</b> <b>TUCSON (NX4A)</b>
<b>SUBJECT:</b> <b>AUTOMATIC TRANSAXLE ATF LEAK AT REAR COVER</b>

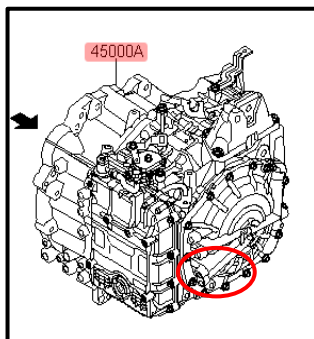
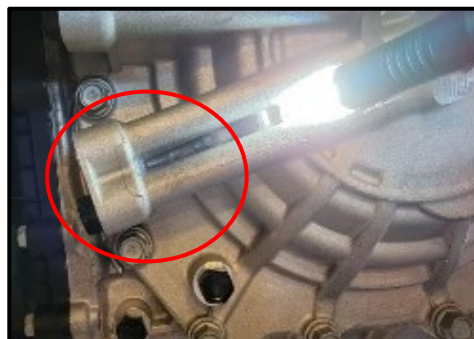
**DESCRIPTION:** Certain vehicles equipped with 8-speed automatic transmission may experience an automatic transmission fluid (ATF) leak at the rear cover. This type of leak is caused by a porous casting on the rear cover of the transmission.

- If the transmission is leaking from the rear cover near the pressure port check plug, replace the automatic transaxle according to the applicable vehicle shop manual.

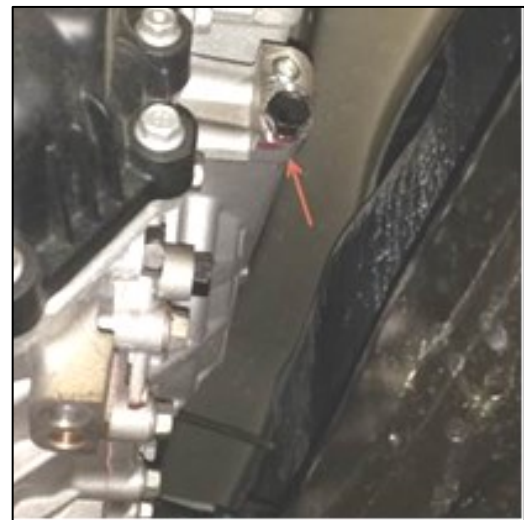
DO NOT replace the rear cover of the automatic transaxle. The rear cover controls the end-play on the disk set and clutch pack. If the selectable spacers are not changed to correct the end play for the new rear cover, the durability of the transmission could be affected.
