**HYUNDAI**
Technical Service Bulletin

GROUP	NUMBER
Body Electrical	21-BE-014H
DATE	MODEL(S)
October, 2021	Accent (HC)

SUBJECT: ACCENT (HC) TRANSPORTATION SHIPPING FUSE INSPECTION GUIDELINES

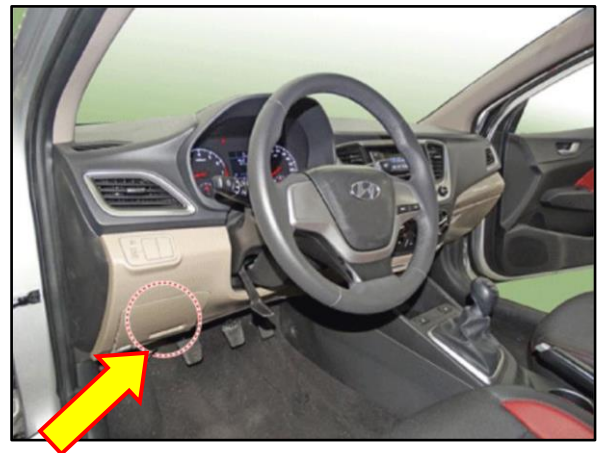
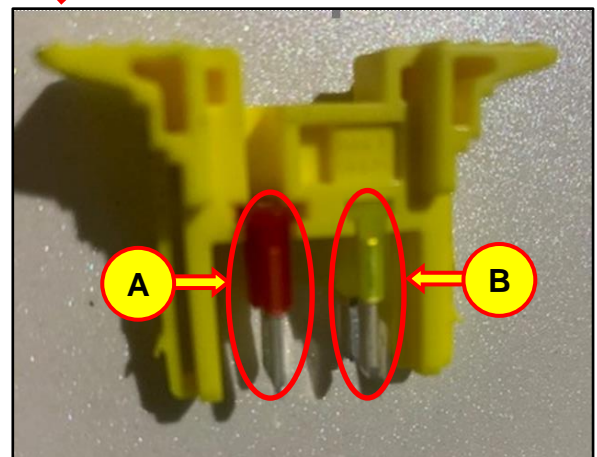
Description: If a vehicle arrives at the dealership with the symptoms below, follow the procedures outlined in this bulletin to ensure that the shipping fuse is completely seated in the junction box.

- TPMS Lamp ON
- Trunk Open Warning Lamp ON while trunk is closed
- Master Warning Mode Lamp ON
- Interior lights inoperative
- Audio system inoperative

1. Locate the lower driver side junction box and remove the cover.
2. In the lower driver side junction box, verify that the Audio Fuse (A) and Room Fuse (B) are not blown. If fuses are blown, replace with fuses of equivalent amperage ratings.
