<b>HYUNDAI</b> <b>Technical Service Bulletin</b>	GROUP <b>Engine</b>	NUMBER <b>21-EM-011H</b>
	DATE <b>October, 2021</b>	MODEL(S) <b>Sonata N-Line (DN8a)</b>
<b>SUBJECT</b> DN8A N-LINE EXHAUST TIP ALIGNMENT

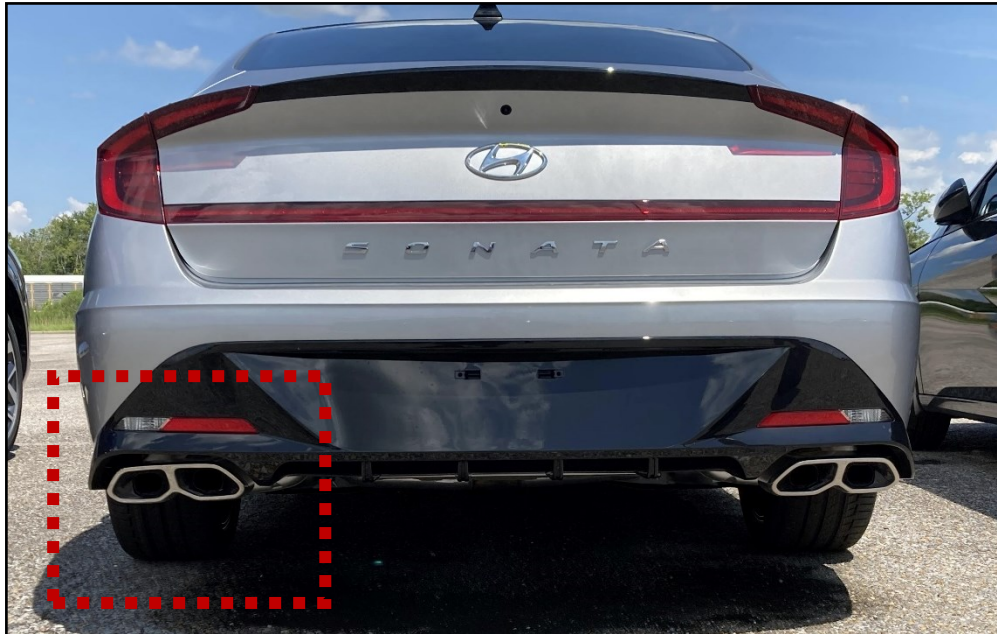
**Description:** Certain Sonata N-Line vehicles may have an uneven appearance between LH and RH exhaust tips due to slightly misaligned rear mufflers. This bulletin describes the procedure to adjust and realign the rear mufflers to correct the appearance.
